**BMW 1: 1HDU601**

Vinnnumber:	<b>WBA1C91020P693219</b>	Versionname:	<b>1 HATCH 116d Eff.Dyn.Ed. 116PK</b>
First Registrationdate:	<b>26/06/2014</b>	Fiscalpower:	
Expertise Mileage:	<b>124565</b>	Power Kw:	<b>85</b>
Bodytype:		Body color:	<b>Grey</b>
Gearbox:	<b>MAN 6 VIT</b>	Paint type:	<b>Metalic</b>
Transmission:		Rims summer:	<b>Aluminium</b>
Fueltype:	<b>Diesel</b>	Oil level:	<b>OK</b>
Battery functioning:	<b>Yes</b>	Parking lot:	<b>3333</b>
Number of doors:	<b>5</b>		
Number of seats:	<b>5</b>		
Number head rests:	<b>5</b>		
Rims summer:	<b>Aluminium</b>		
Category:	<b>Passenger Car</b>		
Oil level:	<b>OK</b>		
Registration Certificate Car (BE):	<b>Yes</b>

**Limited Technical Inspection**

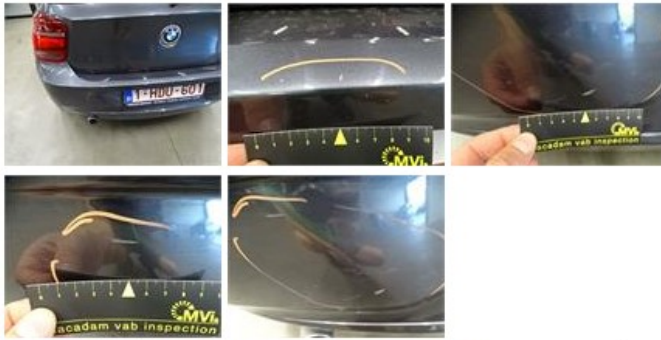
Bumper R, Scratch(es), LI - Repair and paint (complete) 211,80
