**TOYOTA AURIS: 1PJL796**

**Limited Technical Inspection**

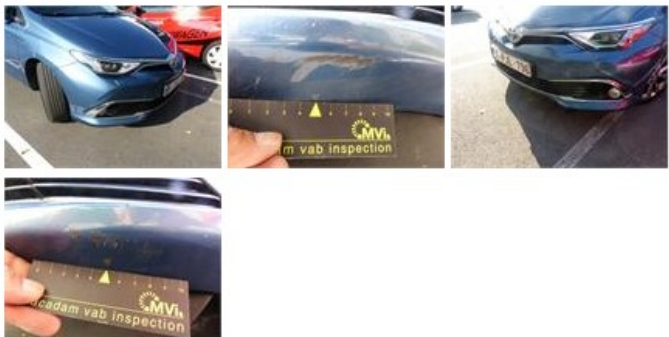
Front bumper, Scratch(es), Acceptable **0,00**
