SEAT Alhambra: 1GD1415			
Vinnnumber:	<b>VSSZZZ7NZEVS11701</b>	Versionname:	<b>ALHAMBRA Ecom.Style DPF 136PK</b>
First Registrationdate:	<b>7/01/2014</b>	Fiscalpower:	
Expertise Mileage:	<b>172987</b>	Power Kw:	<b>100</b>
Bodytype:	<b>SUV</b>	Body color:	<b>Grey</b>
Gearbox:	<b>MAN 6 VIT</b>	Paint type:	<b>Metalic</b>
Transmission:		Rims summer:	<b>Aluminium</b>
Fueltype:	<b>Diesel</b>	Oil level:	<b>OK</b>
Battery functioning:	<b>Yes</b>	Parking lot:	<b>4402</b>
Number of doors:	<b>5</b>		
Number of seats:	<b>5</b>		
Number head rests:	<b>5</b>		
Rims summer:	<b>Aluminium</b>		
Category:	<b>Passenger Car</b>		
Oil level:	<b>OK</b>		
Registration Certificate Car (BE):	<b>Yes</b>

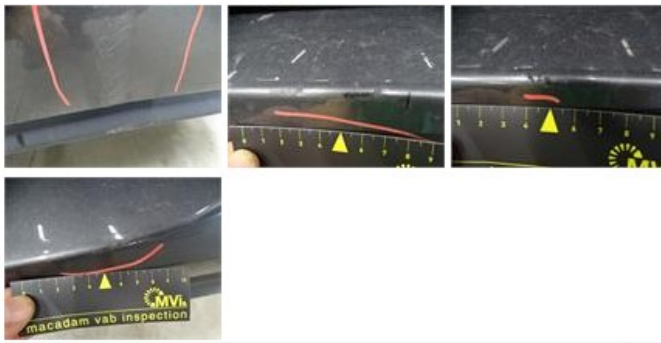
Bumper R, Dent(s) and scratch(es), LI - Repair and paint (complete)	254,16
---	--------

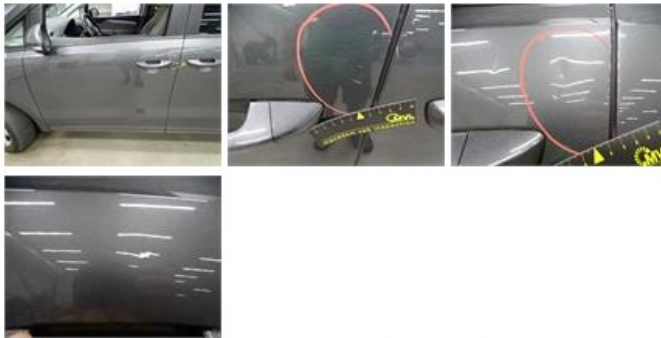
Door F L, Dent(s) and scratch(es), LI - Repair and paint (complete) 382,02

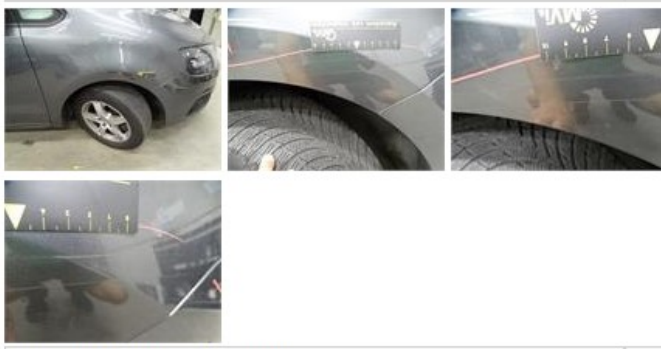
Wing F R, Scratch(es), LI - Repair and paint (complete) 264,21

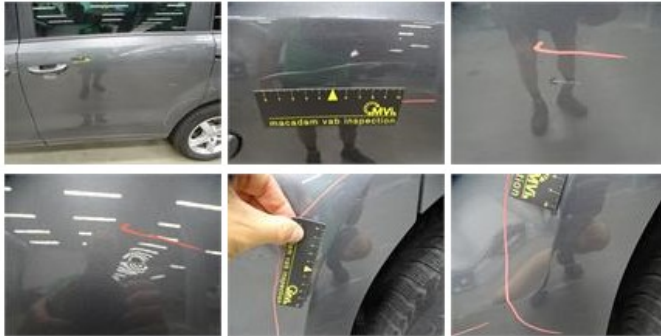
Door R L, Scratch(es), LI - Repair and paint (complete) 382,02

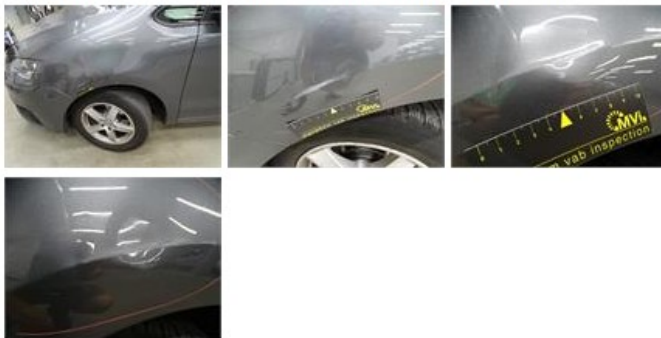
Wing F L, Dent(s) and scratch(es), LI - Repair and paint (complete) 264,21

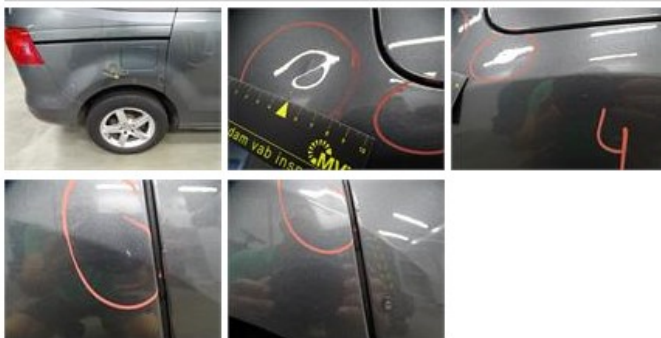
Wing R R, Dent(s) and scratch(es), LI - Repair and paint (complete) 369,84
