TOYOTA Auris: 1FNT352

Limited Technical Inspection

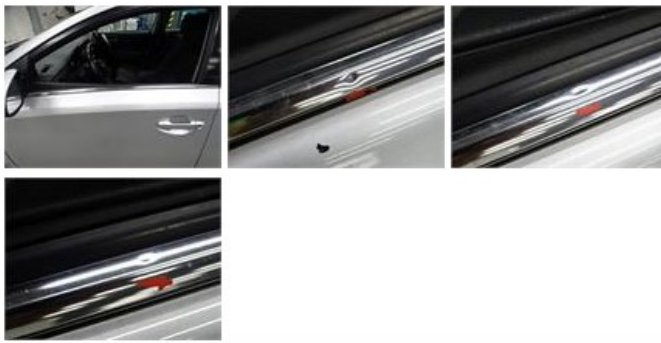
Side window trim F L, Dent(s), E - Replace 20,00

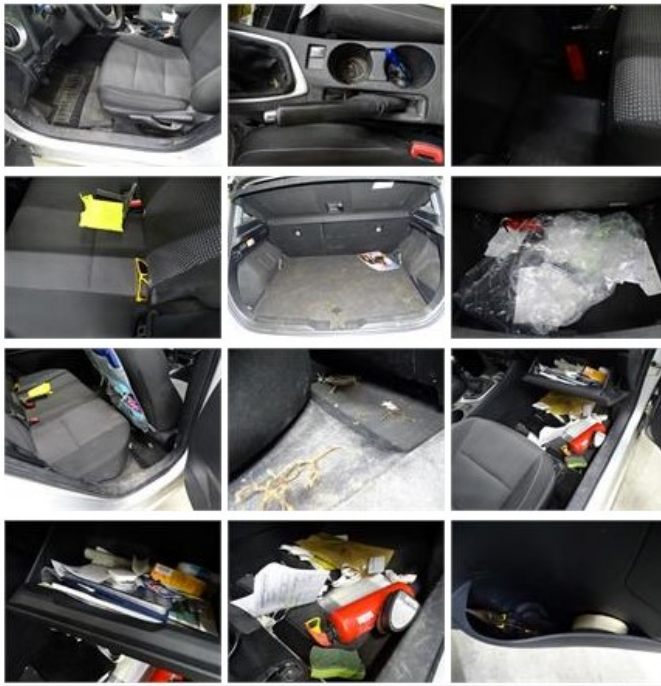
Interior, Dirty, Cleaning 50,00

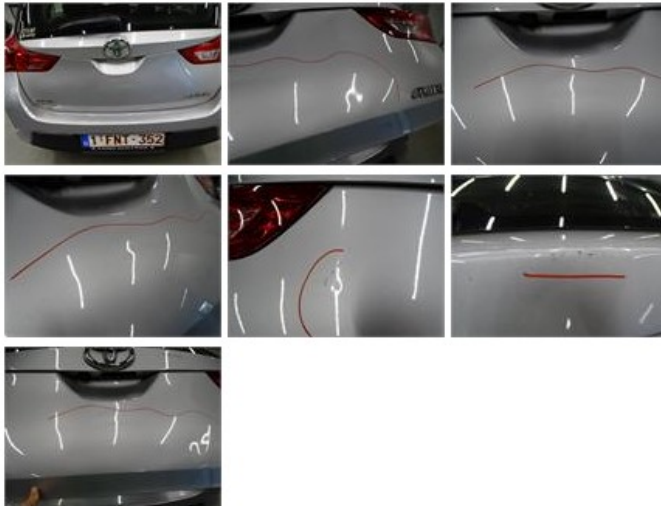
Tailgate, Dent(s), LI - Repair and paint (complete) 301,68

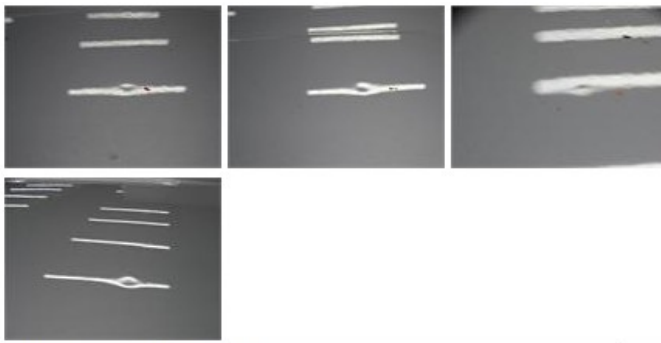
Roof, Hail damage, PDR - Hail 0,00

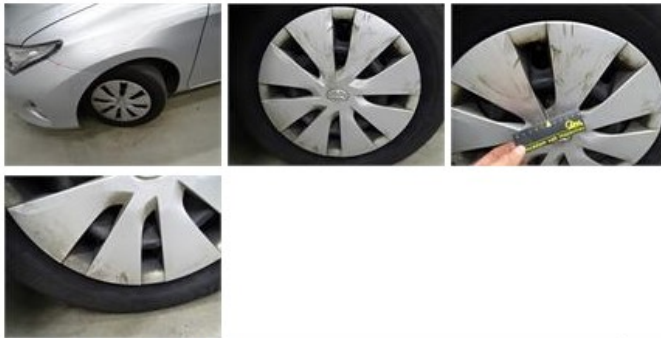
Wheel cover F L, Scratch(es), E - Replace 30,00

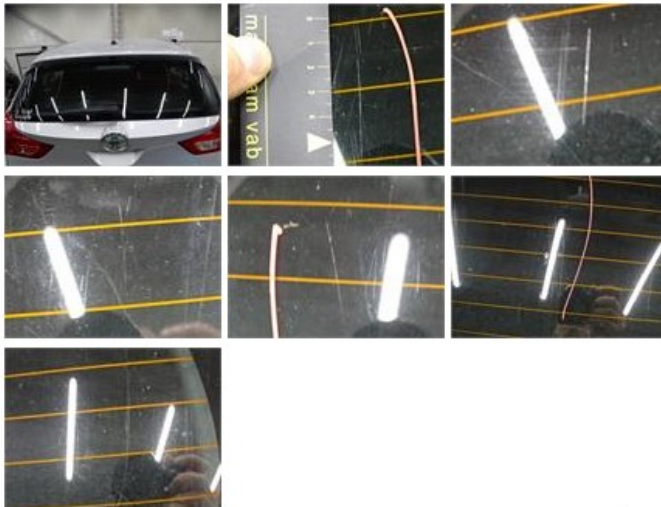
Rear window, Scratch(es), E - Replace 0,00

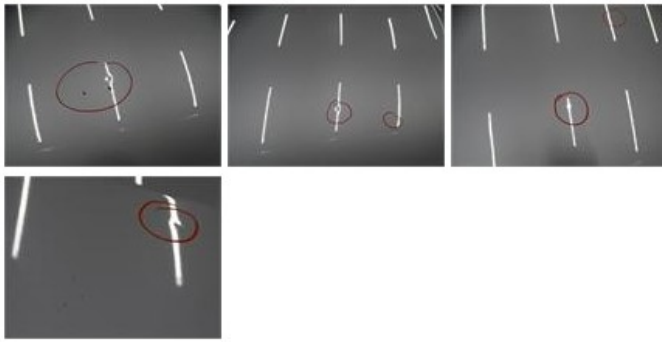
Bonnet, Hail damage, PDR - Hail 0,00
