VOLKSWAGEN Golf: 1EFU884

Limited Technical Inspection

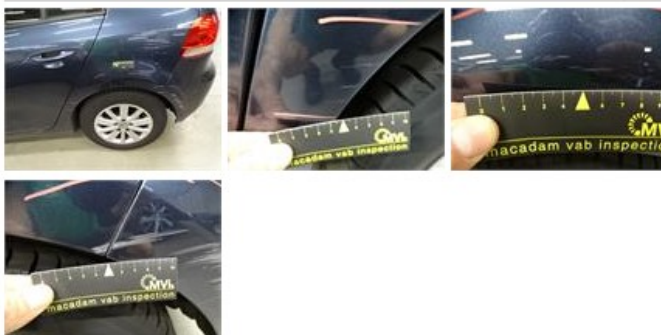
Wing R L, Scratch(es), LI - Repair and paint (complete) 308,20
