<b>VOLVO S60: 1FLQ766</b>			
Vinnumber:	<b>YV1FS84A1D2230975</b>	Versionname:	<b>S60 BER D2 Kinetic St/St</b>
First Registrationdate:	<b>8/08/2013</b>	Fiscalpower:	<b>115PK</b>
Expertise Mileage:	<b>154648</b>	Power Kw:	<b>84</b>
Bodytype:		Body color:	<b>Grey</b>
Gearbox:	<b>MAN 6 VIT</b>	Paint type:	<b>Metalic</b>
Transmission:		Rims summer:	<b>Aluminium</b>
Fueltype:	<b>Diesel</b>	Oil level:	<b>OK</b>
Battery functioning:	<b>Yes</b>	Parking lot:	<b>2222</b>
Number of doors:	<b>4</b>		
Number of seats:	<b>5</b>		
Number head rests:	<b>5</b>		
Rims summer:	<b>Aluminium</b>		
Category:	<b>Passenger Car</b>		
Oil level:	<b>OK</b>

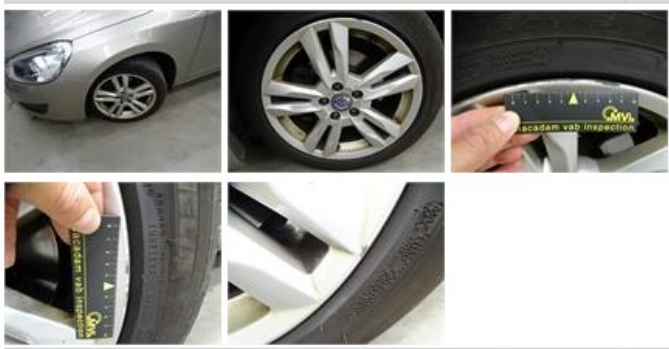
<b>Assistance equipment</b>			
Repair kit	<b>Yes</b>	Compressor	<b>Yes</b>
<b>Total cost ex VAT</b>			<b>786,88</b>
<b>Alloy rim F L, Scratch(es), LI - Repair and paint (complete)</b>			<b>95,00</b>

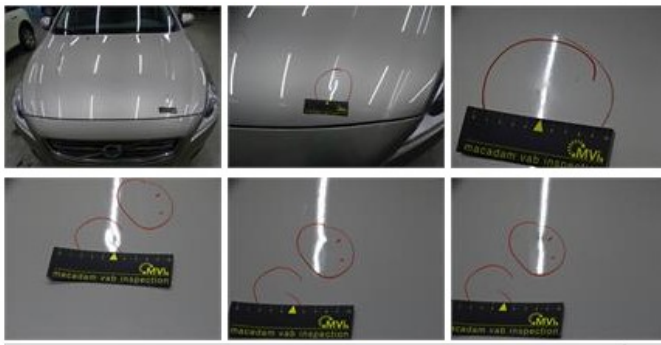
<b>Bonnet, Dent(s) and scratch(es), LI - Repair and paint (complete)</b>	<b>290,08</b>
--	---------------

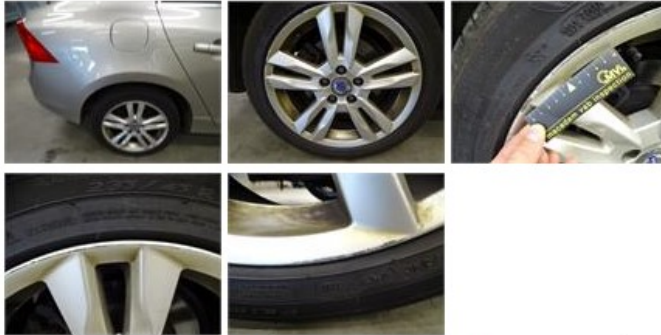
Alloy rim R R, Scratch(es), LI - Repair and paint (complete) 95,00

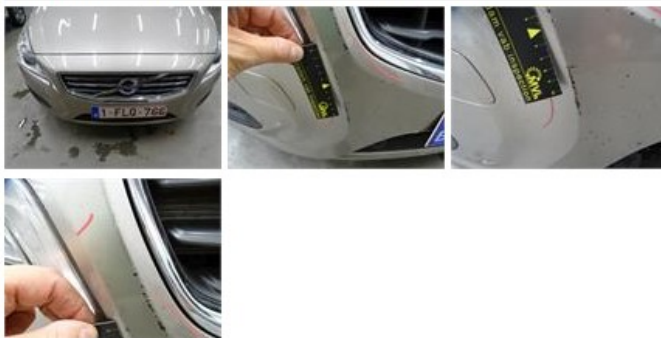
Front bumper, Scratch(es), LI - Repair and paint (complete) 211,80

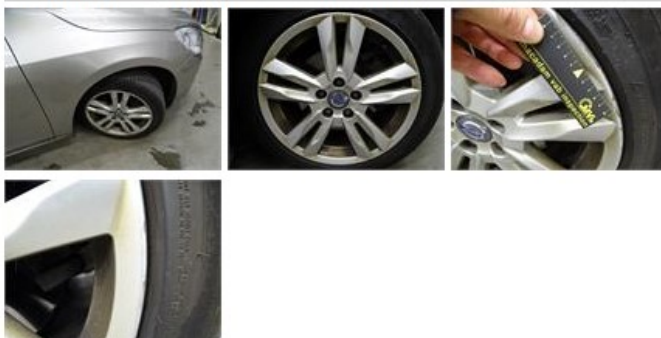
Alloy rim F R, Scratch(es), LI - Repair and paint (complete) 95,00
