## VOLVO V40: 1JLY700

## Limited Technical Inspection

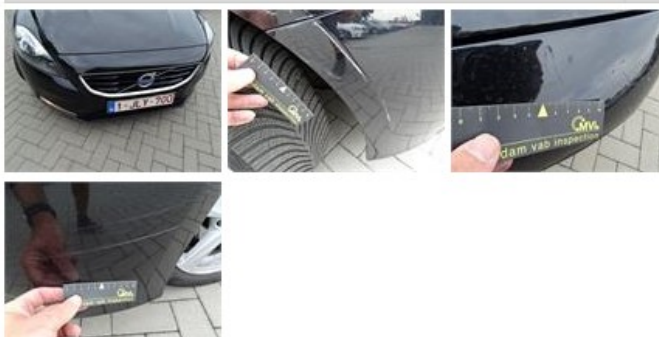
Front bumper, Dent(s) and scratch(es), LI - Repair and paint (complete)	211,80
---	--------
