VOLVO XC60: 1GTK333			
Vinnnumber:	YV1DZ31A1E2575495	Versionname:	XC60 D3 Kinetic 136PK
First Registrationdate:	24/04/2014	Fiscalpower:	
Expertise Mileage:	175114	Power Kw:	100
Bodytype:	SUV	Body color	Dark Blue
Gearbox:	MAN 6 VIT	Paint type	Metalic
Transmission:		Rims summer	Aluminium
Fueltype:	Diesel	Oil level	OK
Battery functioning	Yes	Parking lot	2227
Number of doors	5		
Number of seats	5		
Number head rests	5		
Rims summer	Aluminium		
Category	Passenger Car		
Oil level	OK		
Registration Certificate Car (BE)	Yes

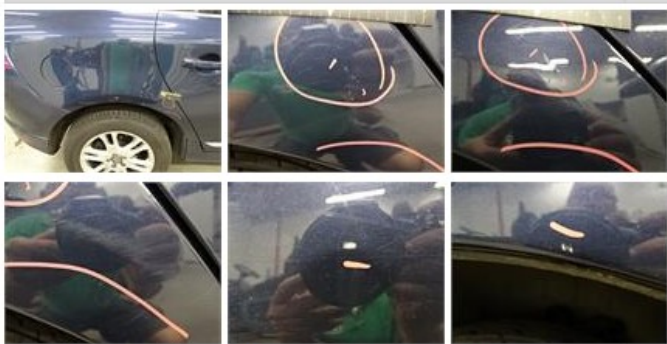
Assistance equipment			
Repair kit	Yes	Compressor	Yes
Total cost ex VAT			1745,58
Wing R R, Dent(s) and scratch(es), LI - Repair and paint (complete)			369,84

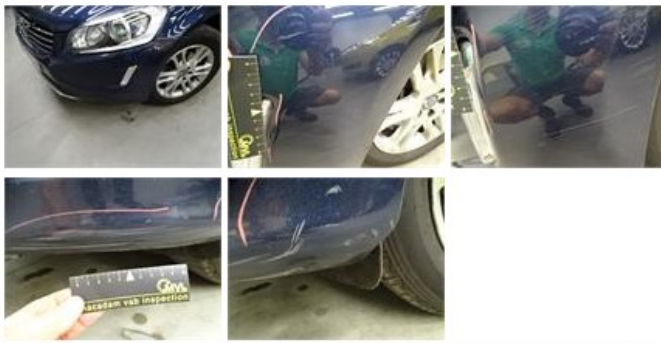
Front bumper, Scratch(es), LI - Repair and paint (complete) 254,16

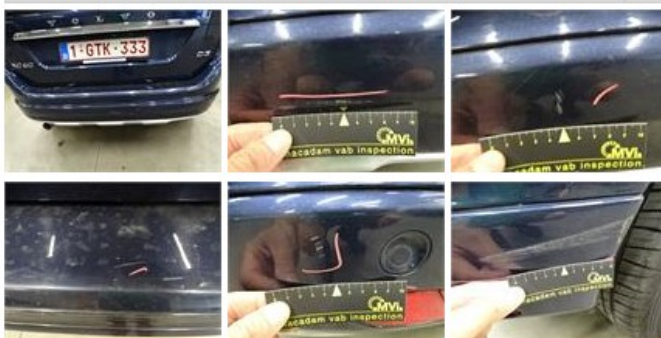
Bumper R, Scratch(es), LI - Repair and paint (complete) 254,16

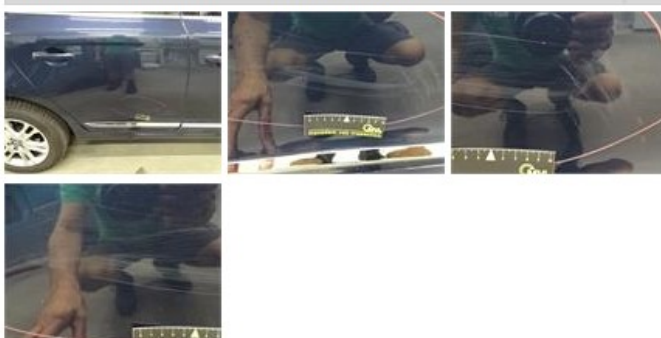
Door R R, Scratch(es), LI - Repair and paint (complete) 382,02
