VOLKSWAGEN Golf: 1FIH005

Limited Technical Inspection

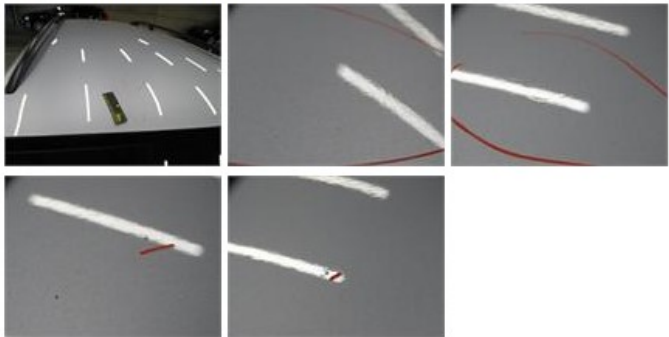
Wing R L, Dent(s), Acceptable	0,00
<i>No pictures to display</i>	
Door frame R R, Dent(s), Acceptable	0,00
<i>No pictures to display</i>	
Bumper R, Scratch(es), Acceptable	0,00
<i>No pictures to display</i>	
Wing F L, Repaired, No repair	0,00
<i>No pictures to display</i>	
Wing F R, Repaired, No repair	0,00
<i>No pictures to display</i>	
Roof, Bad repair, Acceptable	0,00
