PEUGEOT 5008: 1FJO191

Limited Technical Inspection

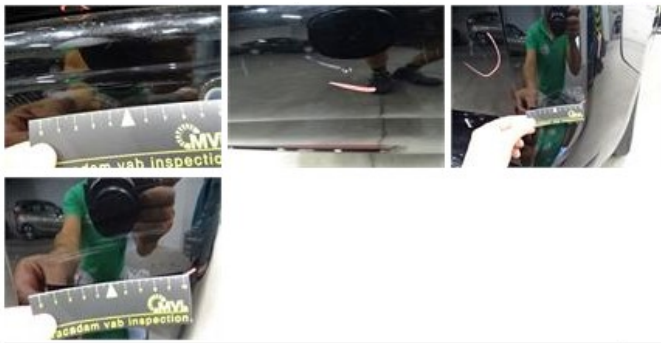
Total cost ex VAT	1647,24
Door F R, Scratch(es), Acceptable	0,00
<i>No pictures to display</i>	
Alloy rim R L, Scratch(es), Acceptable	0,00
<i>No pictures to display</i>	
Bonnet, Stone chip(s), Acceptable	0,00
<i>No pictures to display</i>	
Alloy rim F R, Scratch(es), Acceptable	0,00
<i>No pictures to display</i>	
Bumper R, Scratch(es), LI - Repair and paint (complete)	211,80

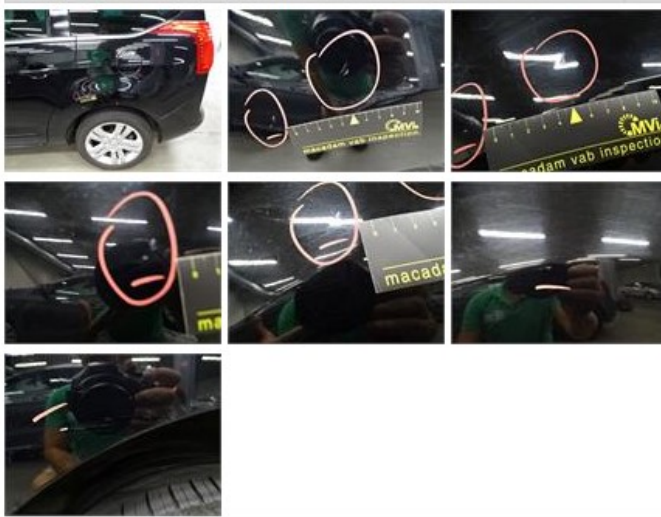
Wing R L, Dent(s) and scratch(es), LI - Repair and paint (complete) 308,20

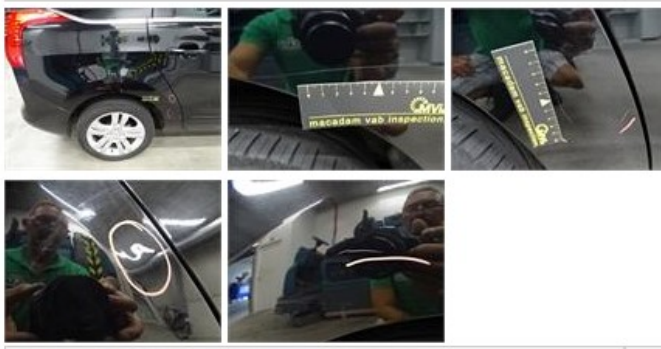
Wing R R, Dent(s) and scratch(es), LI - Repair and paint (complete) 308,20

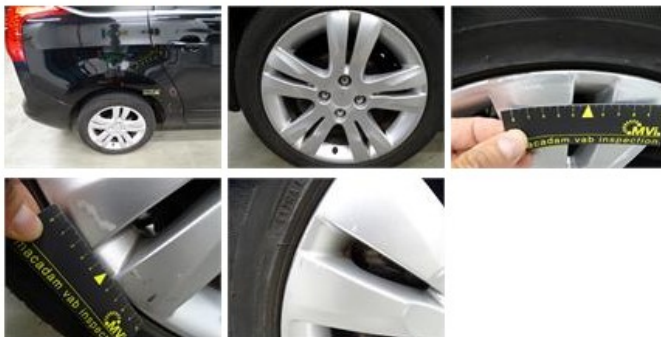
Alloy rim R R, Scratch(es), LI - Repair and paint (complete) 95,00

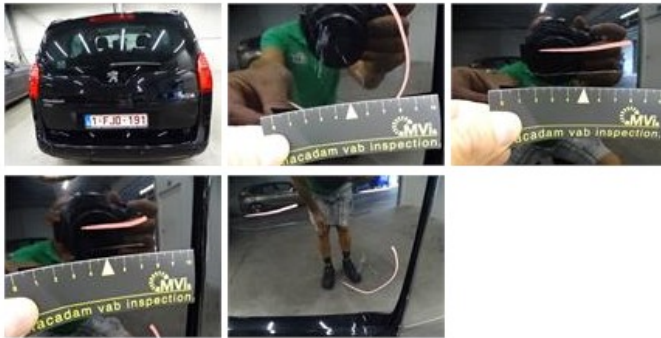
Tailgate, Scratch(es), LI - Repair and paint (complete)

301,68
