BMW SERIE 5 TOURING: 1ETE156

| Vinnumber: | WBAMX11050DY13714 | Versionname: | 520dA |

Limited Technical Inspection

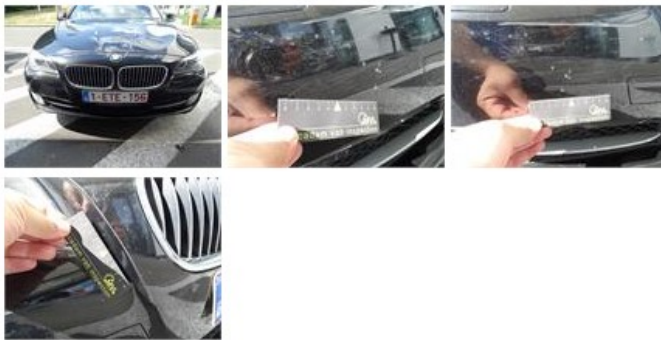
Front bumper, Scratch(es), LI - Repair and paint (complete) 254,16

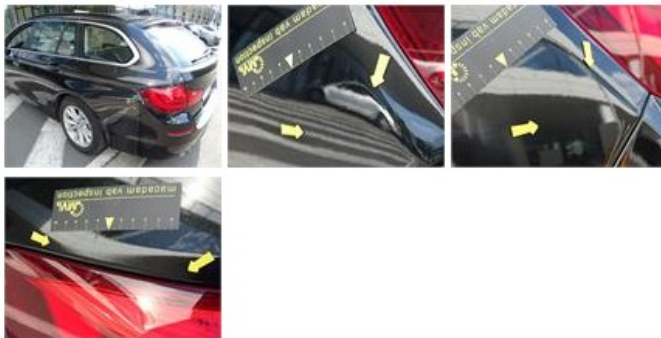
Wing R L, Bad repair, P - Check 0,00

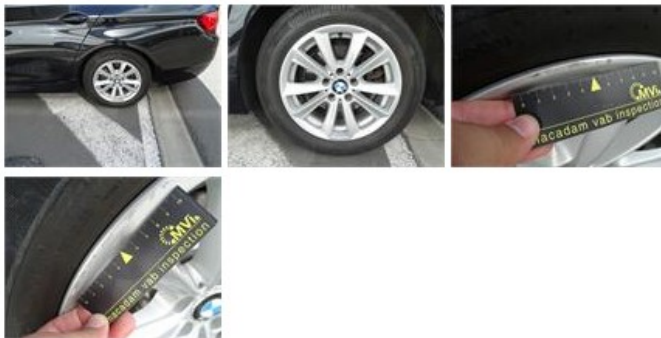
Alloy rim R L, Scratch(es), LI - Repair and paint (complete) 95,00
