**SKODA Superb: 1HEX903**

**Limited Technical Inspection**

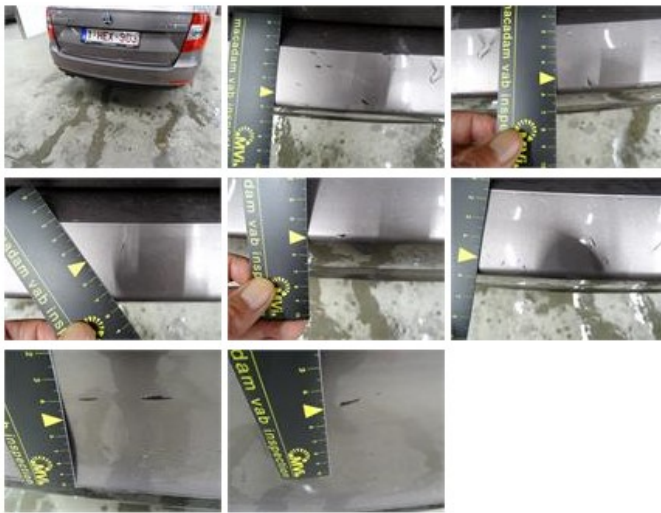
Bumper R, Scratch(es), LI - Repair and paint (complete)	254,16
---	--------
