VOLKSWAGEN Polo: 1GXE107

Limited Technical Inspection

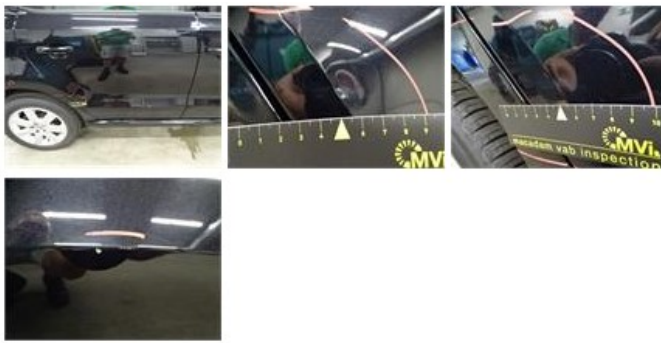
Door R R, Dent(s) and scratch(es), LI - Repair and paint (complete)	254,68
---	--------

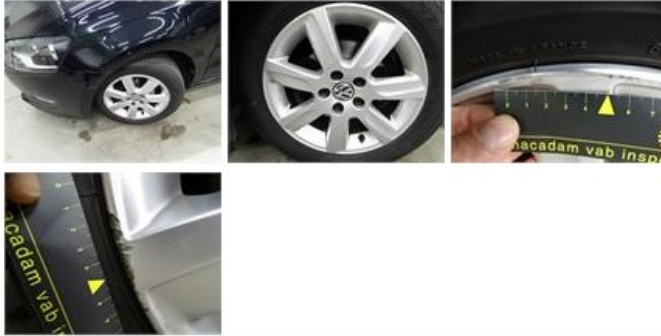
Alloy rim F L, Scratch(es), LI - Repair and paint (complete) 95,00

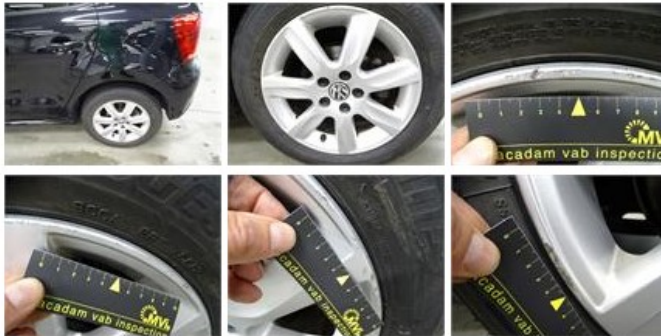
Alloy rim R L, Scratch(es), LI - Repair and paint (complete) 95,00

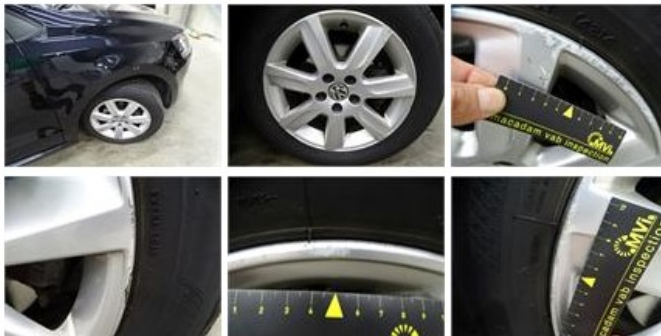
Alloy rim F R, Scratch(es), LI - Repair and paint (complete) 95,00

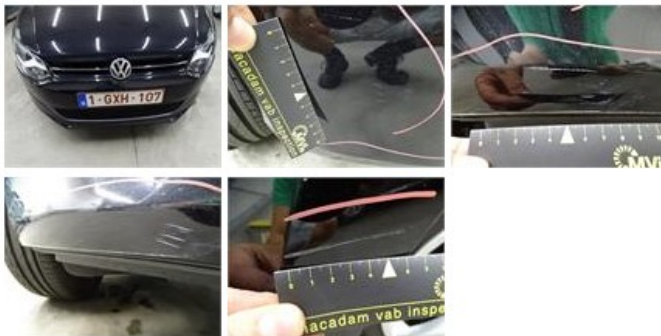
Front bumper, Scratch(es), LI - Repair and paint (complete) 169,44
