VOLVO V40: 1NRC675

Limited Technical Inspection

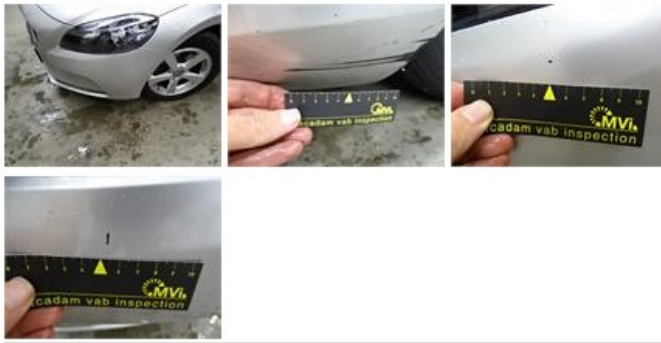
| Front bumper, Scratch(es), LI - Repair and paint (complete) | 211,80 |
