BMW 5: 1DHD499

Limited Technical Inspection

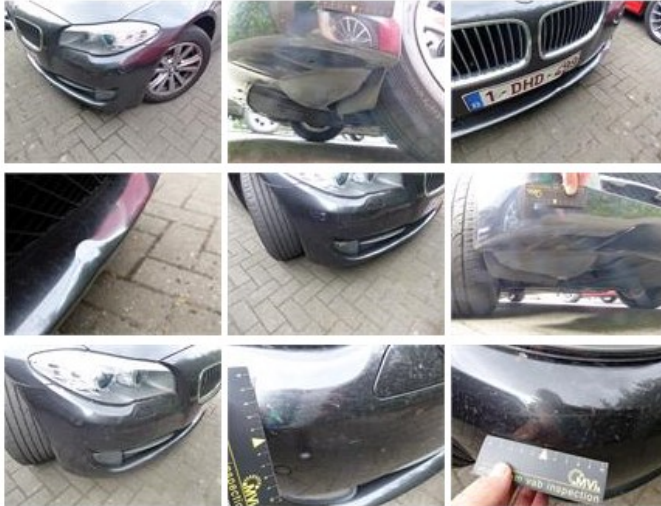
Front bumper, Dent(s) and scratch(es), LI - Repair and paint (complete)	254,16
---	--------
