MERCEDES A: 1LBV163

| Vinnnumber: | WDD1760121V090068 | Versionname: | 1.5 A 180 CDI |

Limited Technical Inspection

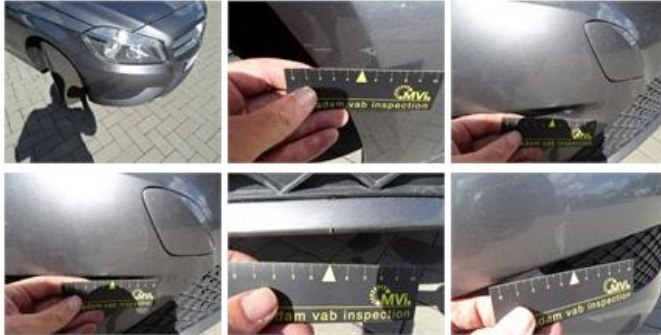
| Front bumper, Scratch(es), LI - Repair and paint (complete) | 211,80 |
