BMW 1: 1FJC895

Limited Technical Inspection

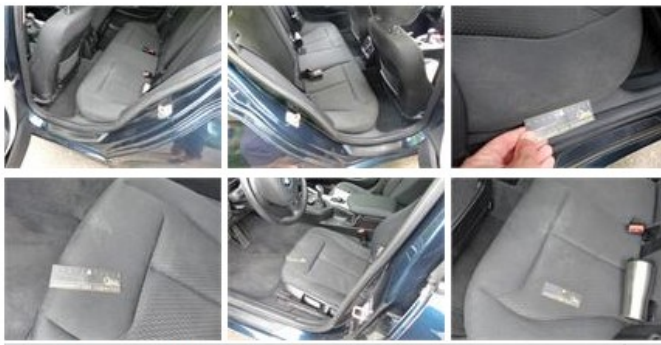
Interior, Dirty, Cleaning	100,00
---------------------------	---------------
