VOLVO V60: 1DNR383

Limited Technical Inspection

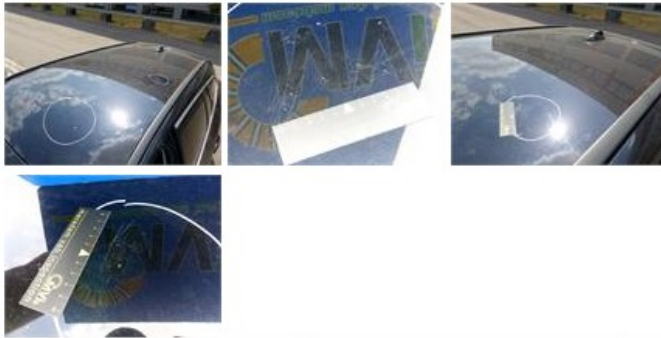
Roof, Chemical pollution, LI - Repair and paint (complete) 481,50

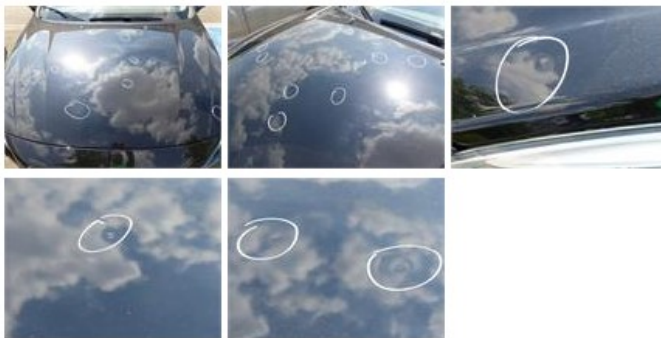
Bonnet, Hail damage, PDR - Hail 275,00

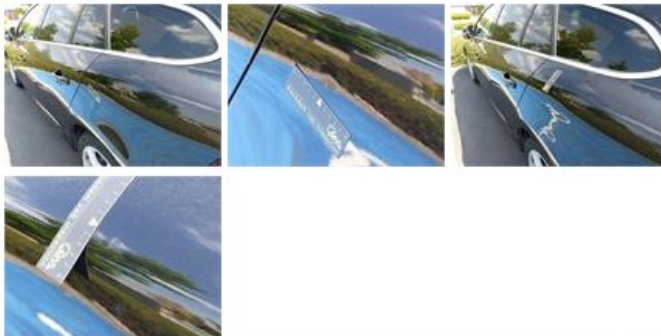
Wing R L, Dent(s), Acceptable 0,00

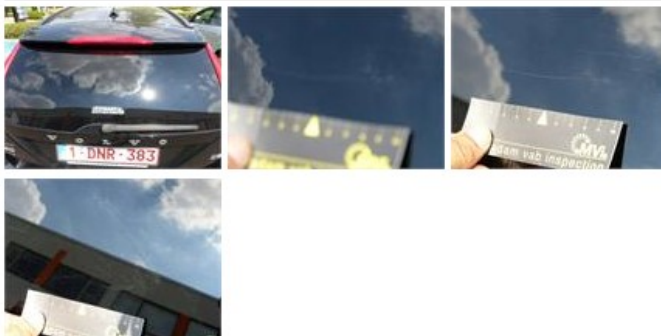
Rear window, Scratch(es), E - Replace 370,00
