OPEL Zafira: 1FMR224

Limited Technical Inspection

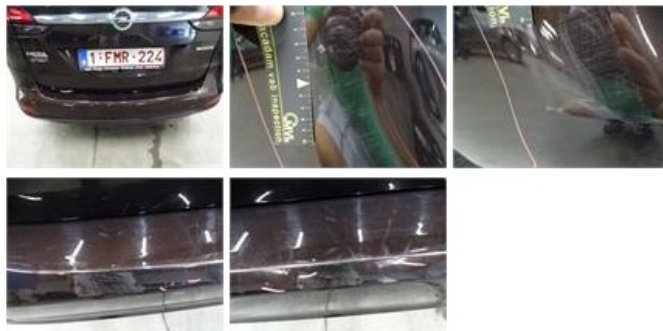
Bumper R, Scratch(es), LI - Repair and paint (complete)	211,80
---	--------

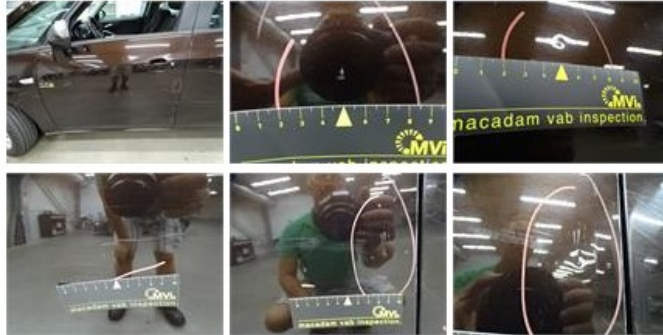
Door F L, Dent(s) and scratch(es), LI - Repair and paint (complete) 318,35

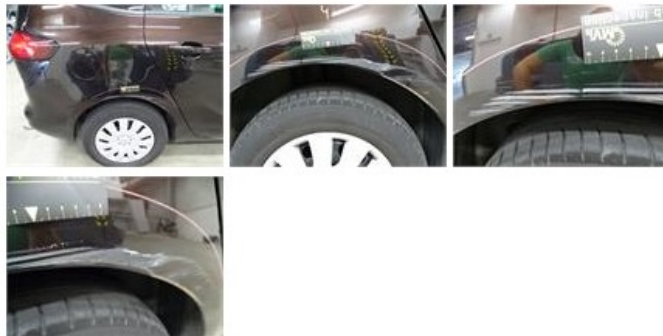
Wing R R, Dent(s) and scratch(es), LI - Repair and paint (complete) 308,20

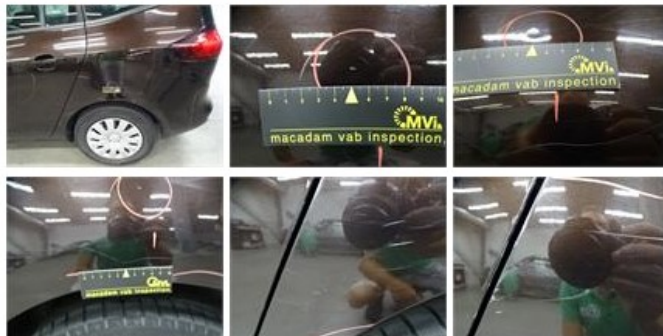
Wing R L, Dent(s) and scratch(es), LI - Repair and paint (complete) 308,20

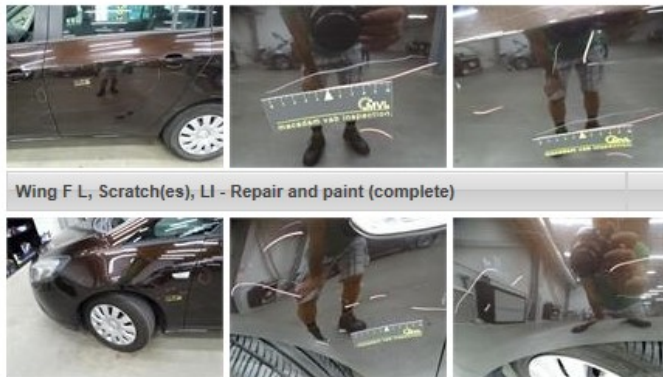
Door R L, Scratch(es), LI - Repair and paint (complete) 318,35
