VOLKSWAGEN Golf: 1ESH216

Limited Technical Inspection

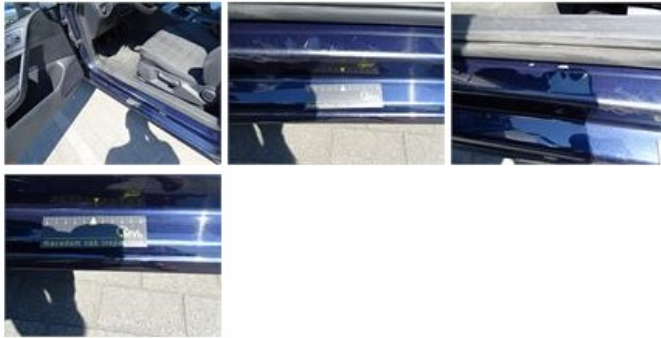
Rocker panel inner F L, Scratch(es), LI - Repair and paint (complete) 115,56

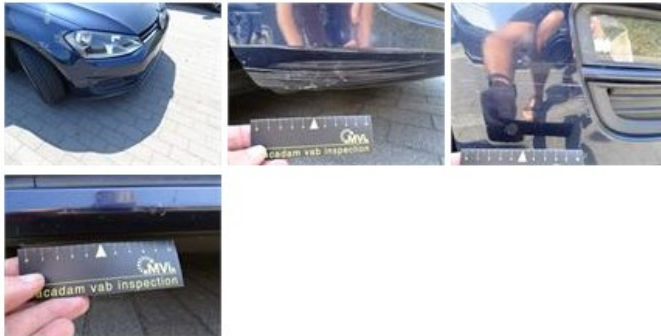
Front bumper, Scratch(es), LI - Repair and paint (complete) 211,80

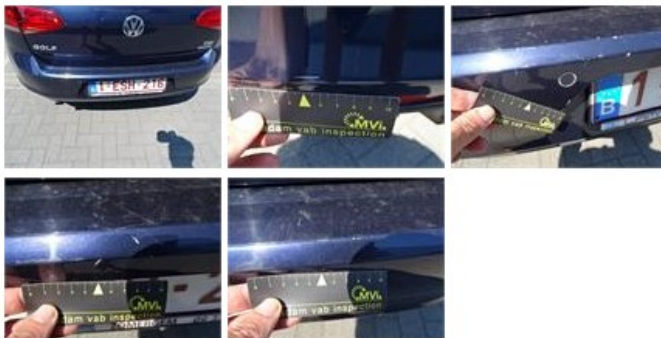
Bumper R, Scratch(es), LI - Repair and paint (complete) 211,80
