AUDI A4: 1EWX219

Limited Technical Inspection

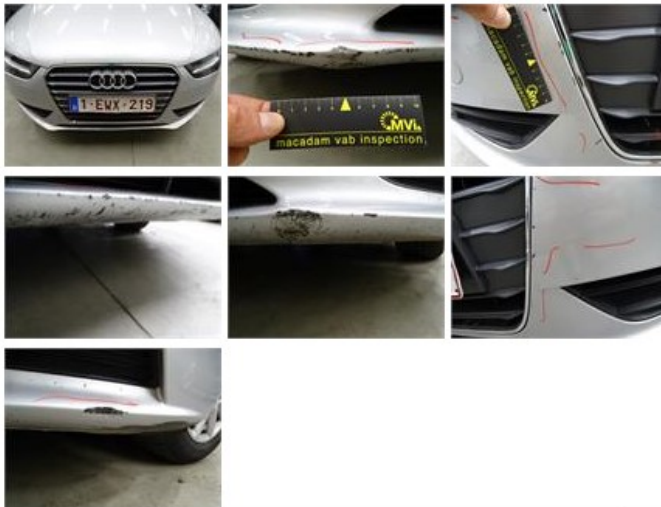
Front bumper, Scratch(es), LI - Repair and paint (complete) 211,80

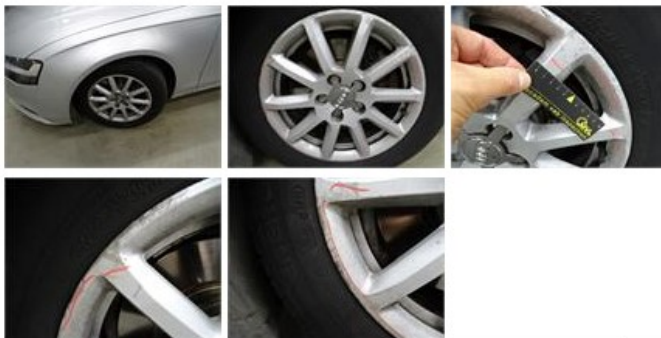
Alloy rim F L, Scratch(es), LI - Repair and paint (complete) 95,00
