**AUDI A3: 1EZL411**

**Limited Technical Inspection**

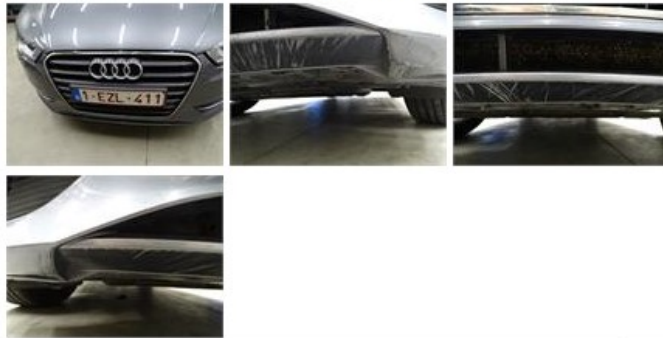
Wing R L, Scratch(es), Acceptable	0,00
<i>No pictures to display</i>	
Door R R, Scratch(es), Acceptable	0,00
<i>No pictures to display</i>	
Front bumper, Scratch(es), LI - Repair and paint (complete)	211,80
