BMW 2 Active Tourer: 1HVZ975

| Vinnnumber: | WBA2C11090V335990 | Versionname: | 2 ACTIVE TOURER 218dA |

Limited Technical Inspection

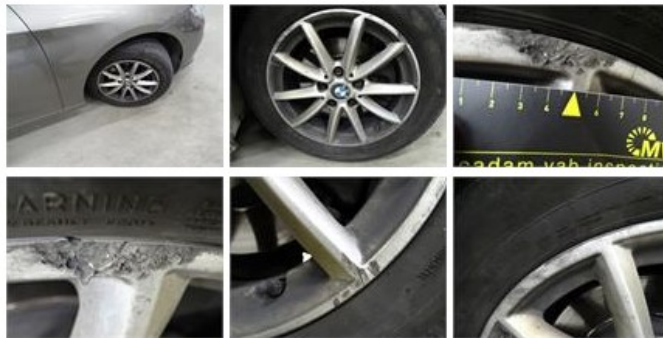
Alloy rim F R, Damaged, E - Replace 235,20

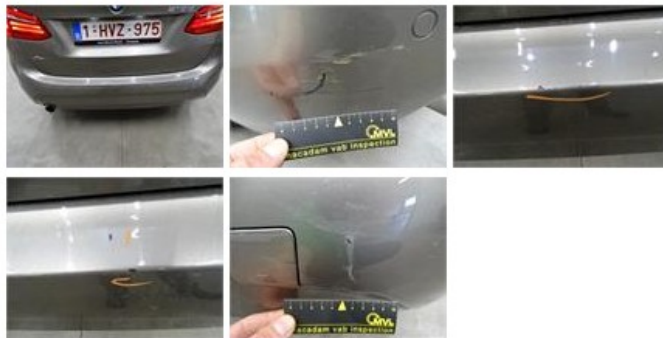
Bumper R, Scratch(es), LI - Repair and paint (complete) 211,80
