**BMW 3: 1GRU452**

**Limited Technical Inspection**

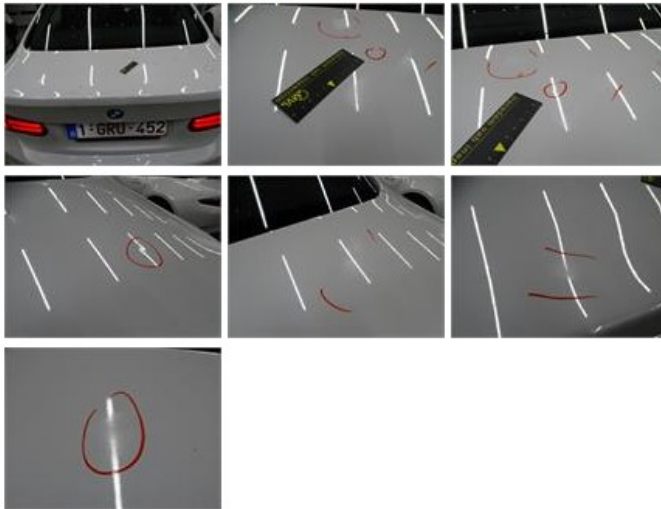
Tailgate, Dent(s) and scratch(es), LI - Repair and paint (complete) 301,68

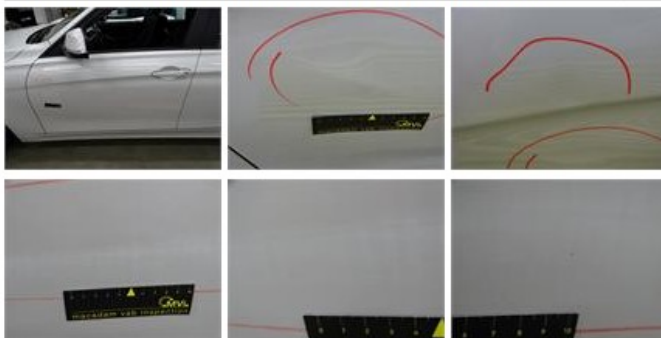
Door F L, Dent(s) and scratch(es), LI - Repair and paint (complete) 318,35
