LAND ROVER Evoque: 1EXM145

Limited Technical Inspection

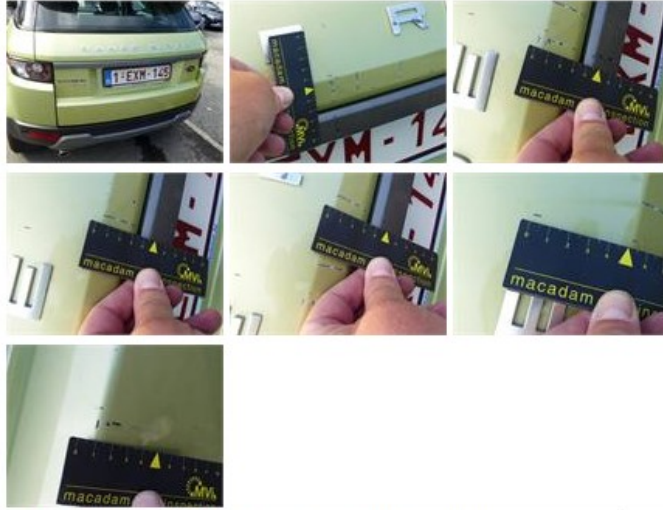
Tailgate, Scratch(es), LI - Repair and paint (complete)

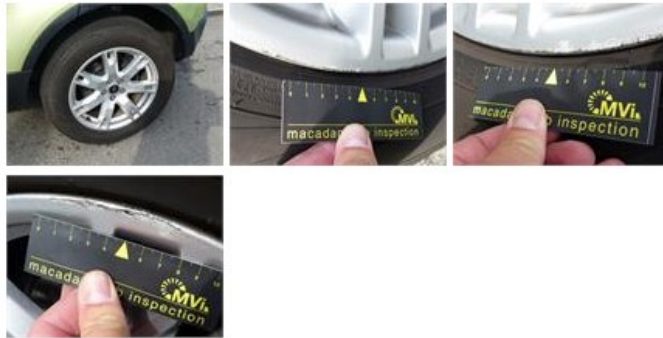
Alloy rim R L, Scratch(es), LI - Repair and paint (complete)
