VOLVO V40: 1ERR438			
Vinnnumber:	YV1MV8481D2038689	Versionname:	V40 D2 Base 115PK
First Registrationdate:	4/03/2013	Fiscalpower:	
Expertise Mileage:	113844	Power Kw:	84
Bodytype:		Body color	Black
Gearbox:	MAN 6 VIT	Paint type	Metalic
Transmission:		Rims summer	Aluminium
Fueltype:	Diesel	Oil level	OK
Battery functioning	Yes	Parking lot	4833
Number of doors	5		
Number of seats	5		
Number head rests	5		
Rims summer	Aluminium		
Category	Passenger Car		
Oil level	OK

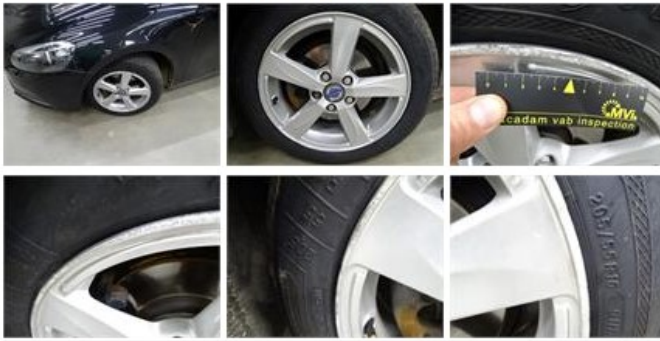
Alloy rim F L, Scratch(es), LI - Repair and paint (complete) 95,00

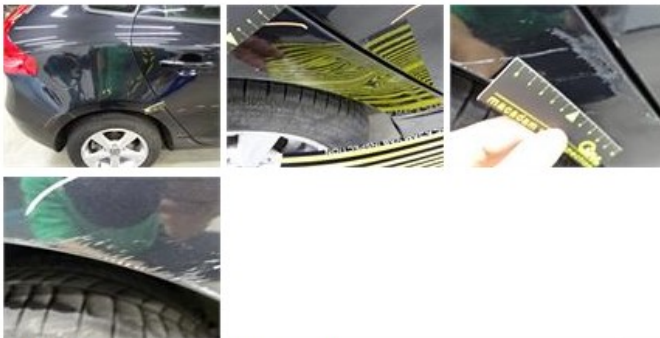
Wing R R, Dent(s) and scratch(es), LI - Repair and paint (complete) 0,00

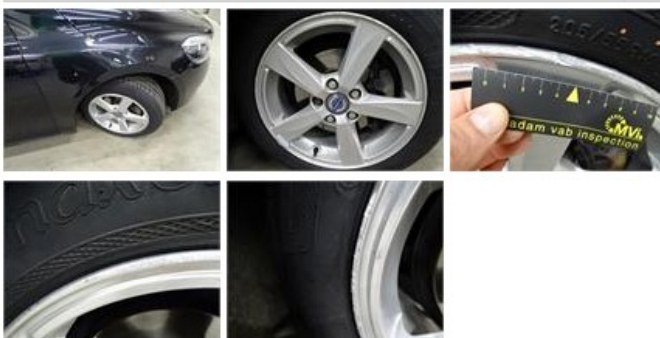
Alloy rim F R, Scratch(es), LI - Repair and paint (complete) 95,00

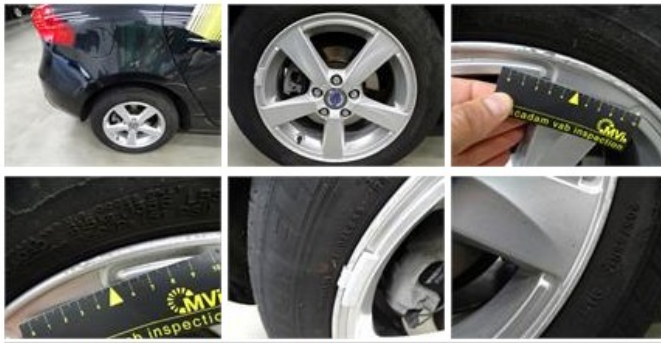
Alloy rim R R, Scratch(es), LI - Repair and paint (complete) 95,00

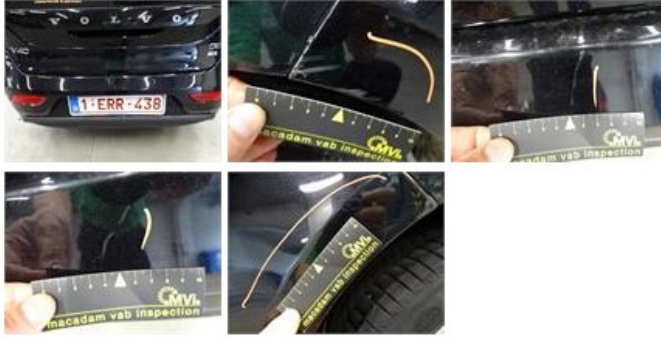
Bumper R, Scratch(es), LI - Repair and paint (complete) 211,80
