VOLVO XC60: 1EMJ355

Limited Technical Inspection

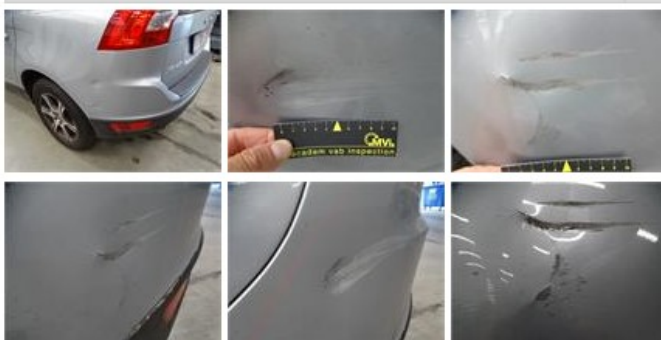
Total cost ex VAT	2636,50
Bumper R, Dent(s) and scratch(es), LI - Repair and paint (complete)	254,16
