SKODA Octavia: 1GPQ367

Limited Technical Inspection

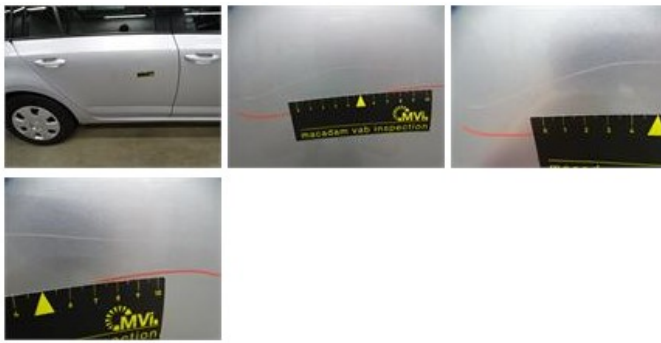
Wing R R, Scratch(es), Acceptable	0,00
<i>No pictures to display</i>	
Bonnet, Dent(s), Acceptable	0,00
<i>No pictures to display</i>	
Door R R, Scratch(es), LI - Repair and paint (complete)	318,35

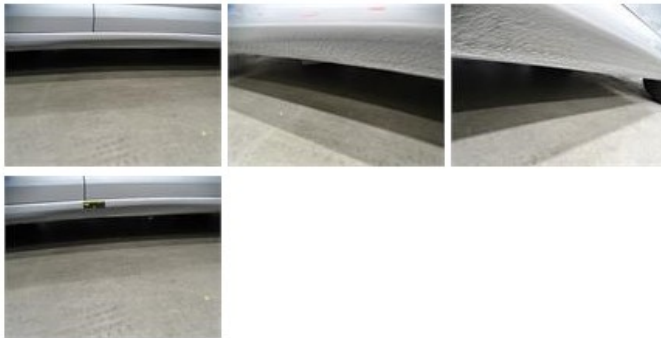
Sill outer R, Dent(s) and scratch(es), Le - Replace and paint 712,00

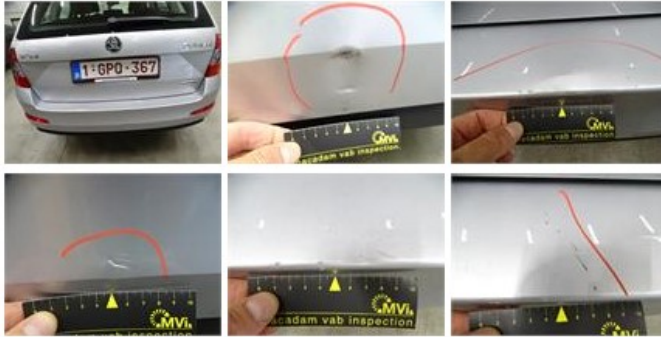
Bumper R, Dent(s) and scratch(es), LI - Repair and paint (complete) 211,80
