BMW 1: 1GDR411

Limited Technical Inspection

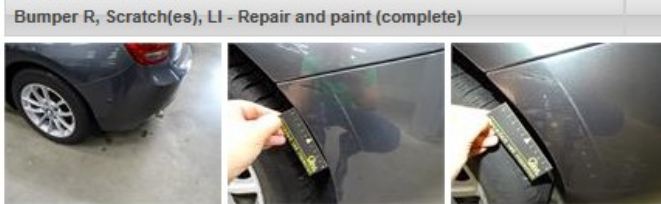
Bumper R, Scratch(es), LI - Repair and paint (complete) 211,80

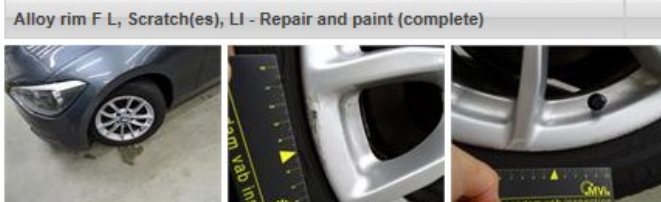
Alloy rim F L, Scratch(es), LI - Repair and paint (complete) 95,00

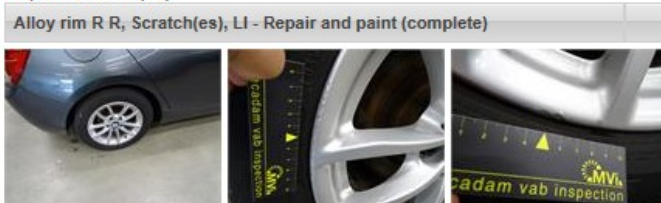
Alloy rim R R, Scratch(es), LI - Repair and paint (complete) 95,00

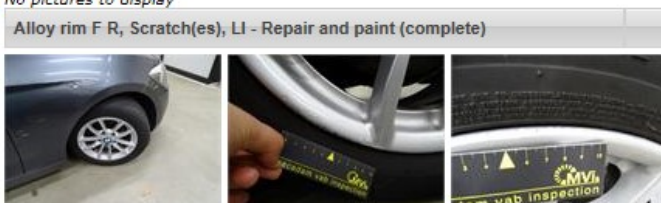
Alloy rim F R, Scratch(es), LI - Repair and paint (complete) 95,00
