| FORD Fiesta: PR8791 | | | |
| Vinnnumber: | <b>WF0DXXGAKDDC60418</b> | Versionname: | <b>FIESTA BER Trend 75PK</b> |

| Limited Technical Inspection | | | |

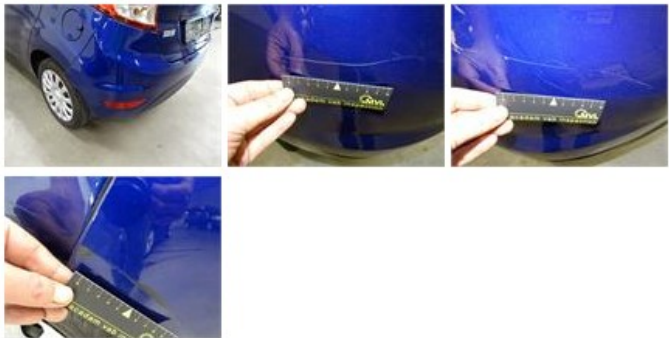
| Assistance equipment | |
|---|---|
| Bumper R, Scratch(es), LI - Repair and paint (complete) | 169,44 |

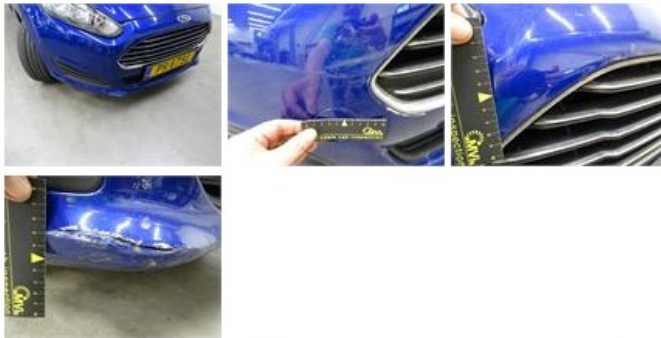
Front bumper, Scratch(es), LI - Repair and paint (complete) 169,44

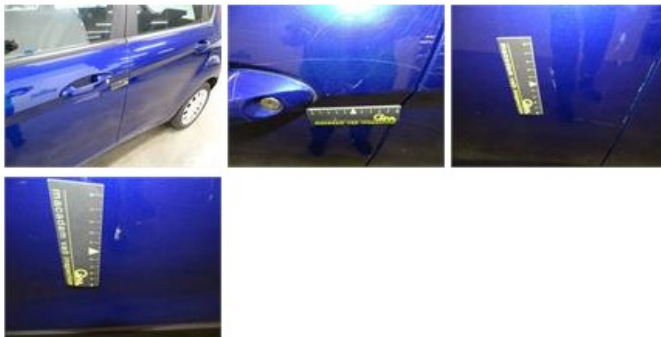
Door F L, Scratch(es), LI - Repair and paint (complete) 254,68

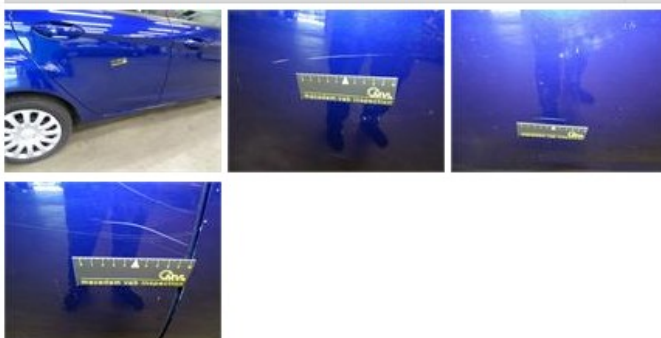
Door R R, Scratch(es), LI - Repair and paint (complete) 254,68
