MERCEDES A: 1FBA205

Vinnumber:	WDD1760001J101163	Versionname:	A 180 CDI BE 109PK Aut.
First Registrationdate:	13/05/2013	Fiscalpower:	
Expertise Mileage:	153980	Power Kw:	80
Bodytype:		Body color:	Black
Gearbox:	Automatic	Paint type:	Metalic
Transmission:	Front	Rims summer:	Aluminium
Fueltype:	Diesel	Oil level:	OK
Maintenance:	NOT OK	Parking lot:	3211
Battery functioning:	Yes		
Number of doors:	5		
Number of seats:	5		
Number head rests:	1		
Rims summer:	Aluminium		
Category:	Passenger Car		
Oil level:	OK

Limited Technical Inspection

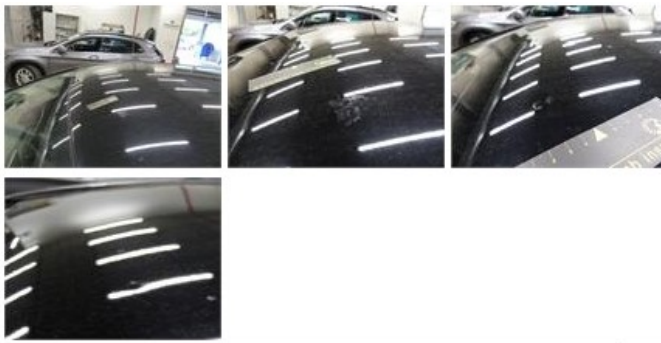
Roof, Chemical pollution, LI - Repair and paint (complete)	481,50
--	--------

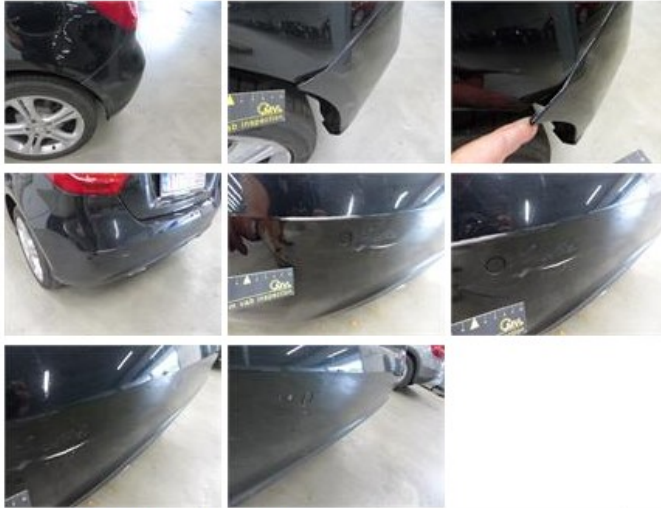
Bumper R, Dent(s) and scratch(es), Le - Replace and paint 651,00

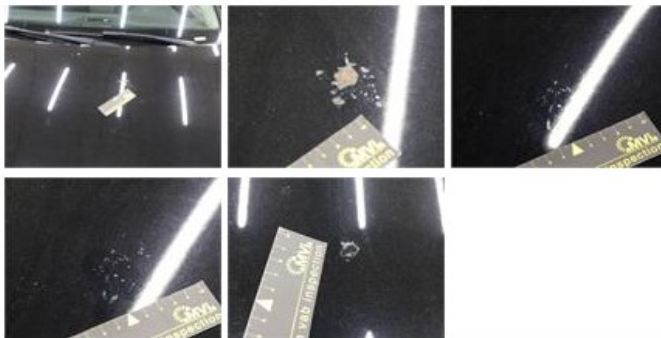
Bonnet, Chemical polution, LI - Repair and paint (complete) 290,08

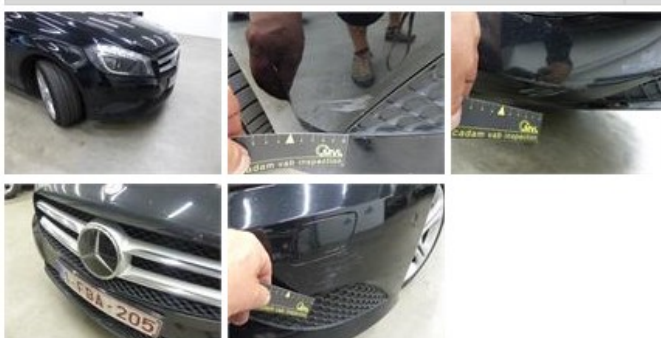
Front bumper, Scratch(es), LI - Repair and paint (complete) 211,80

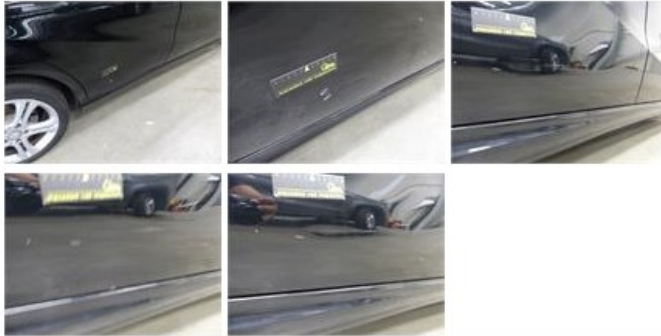
Door R R, Dent(s) and scratch(es), LI - Repair and paint (complete) 390,35
