MERCEDES Sprinter 300: 236AMJ

Limited Technical Inspection

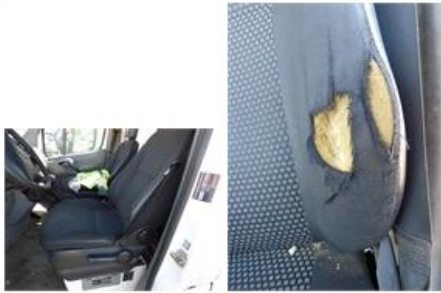
Backrest cover F L, Damaged, E - Replace 300,00
