PEUGEOT Expert: 1GTK322

Limited Technical Inspection

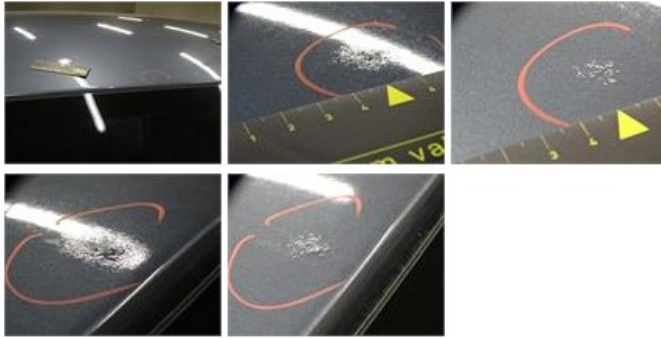
Steel rim F R, Rust, Acceptable	0,00
<i>No pictures to display</i>	
Steel rim F L, Rust, Acceptable	0,00
<i>No pictures to display</i>	
Steel rim R L, Rust, Acceptable	0,00
<i>No pictures to display</i>	
Bumper F L, Scratch(es), Acceptable	0,00
<i>No pictures to display</i>	
Roof, Chemical pollution, LI - Repair and paint (complete)	361,13
