OPEL Astra: 1FHY818

Limited Technical Inspection

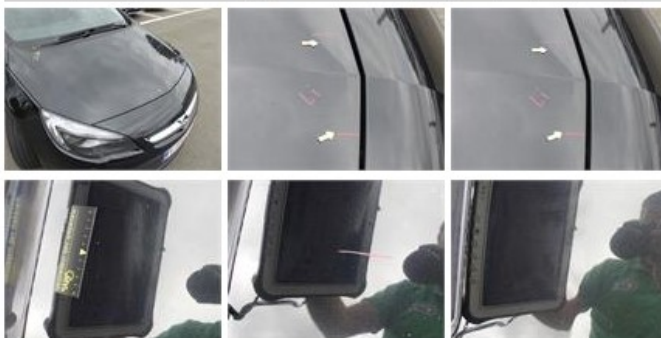
Bonnet, Dent(s) and scratch(es), LI - Repair and paint (complete) **314,08**

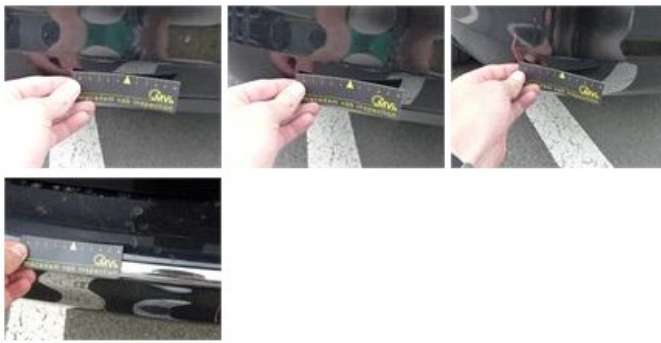
Bumper R, Scratch(es), It - Spot repair 115,56

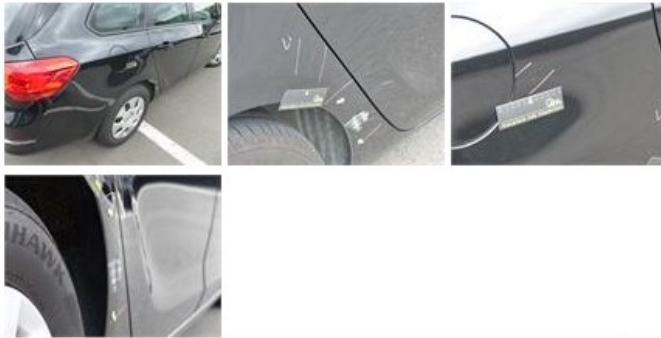
Door R R, Scratch(es), Acceptable	0,00
<i>No pictures to display</i>	
Internal Boot Lining L, Scratch(es), Acceptable	0,00
<i>No pictures to display</i>	
Wing R R, Dent(s) and scratch(es), LI - Repair and paint (complete)	380,20

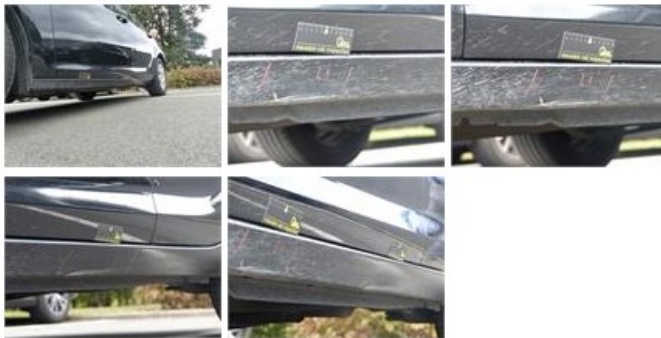
Internal Boot Lining R, Scratch(es), Acceptable	0,00
<i>No pictures to display</i>	
Wheel cover R L, Scratch(es), Acceptable	0,00
<i>No pictures to display</i>	
Tailgate, Dent(s) and scratch(es), Acceptable	0,00
<i>No pictures to display</i>	
Sill outer L, Dent(s) and scratch(es), LI - Repair and paint (complete)	358,50
