**SKODA Octavia: 1HGR506**

**Limited Technical Inspection**

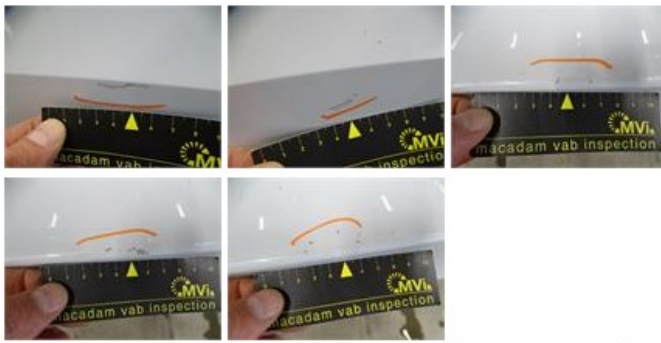
Total cost ex VAT	596,88
Door R R, Dent(s), Acceptable	0,00
<i>No pictures to display</i>	
Front bumper, Scratch(es), Acceptable	0,00
<i>No pictures to display</i>	
Bumper R, Scratch(es), LI - Repair and paint (complete)	211,80

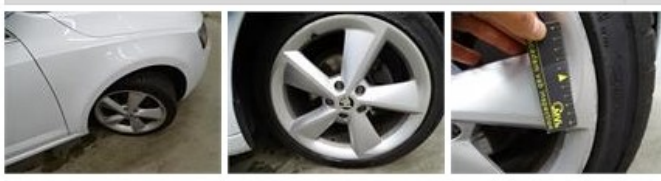
Alloy rim F R, Scratch(es), LI - Repair and paint (complete) 95,00

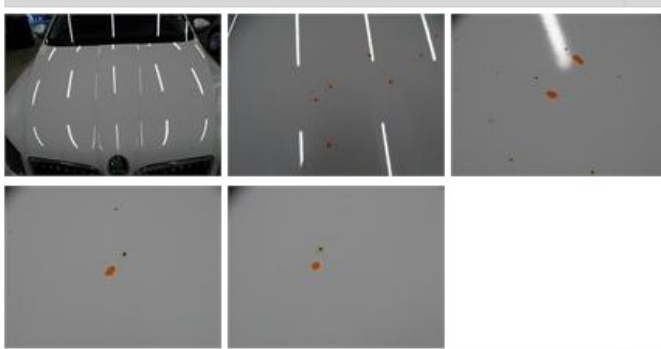
Bonnet, Rust, LI - Repair and paint (complete) 290,08
