SKODA Octavia: 1HNC735

Limited Technical Inspection

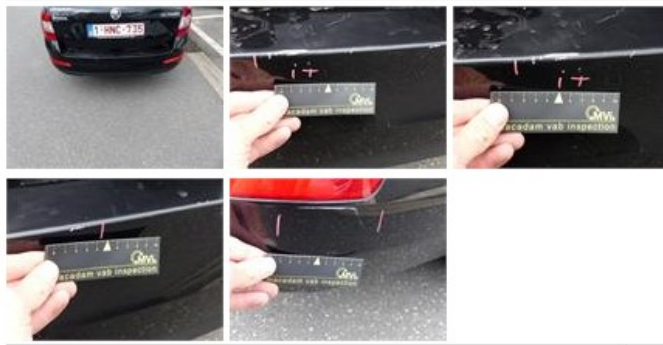
Alloy rim F R, Scratch(es), Acceptable	0,00
<i>No pictures to display</i>	Door F L, Scratch(es), Acceptable	0,00
<i>No pictures to display</i>	Bumper R, Scratch(es), It - Spot repair	115,56

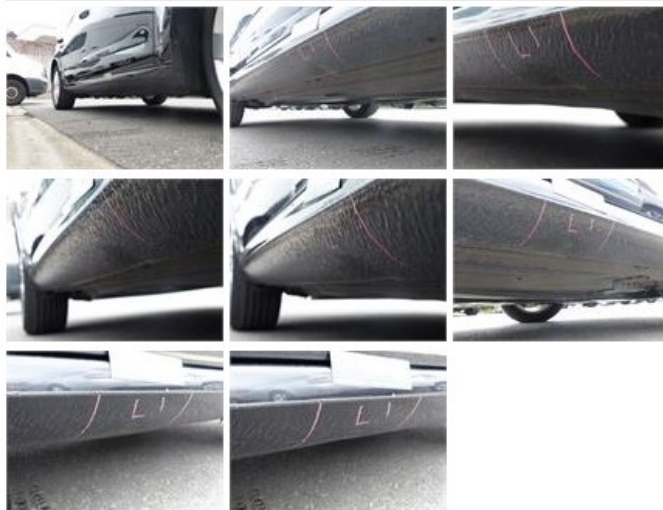
Sill outer R, Dent(s), LI - Repair and paint (complete)	358,50
--	---	--------
