VOLKSWAGEN Golf: 1FSY378

Limited Technical Inspection

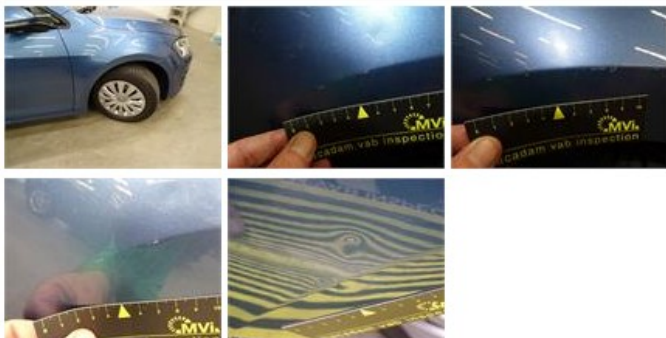
Wing F R, Scratch(es), LI - Repair and paint (complete)
