VOLKSWAGEN Golf: 1HCN593

Limited Technical Inspection

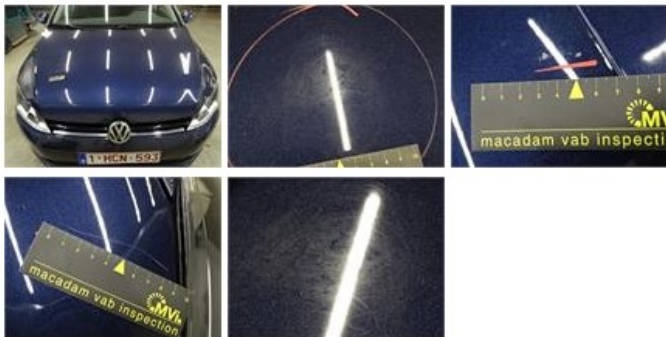
Bonnet, Dent(s) and scratch(es), LI - Repair and paint (complete)	290,08
---	---------------

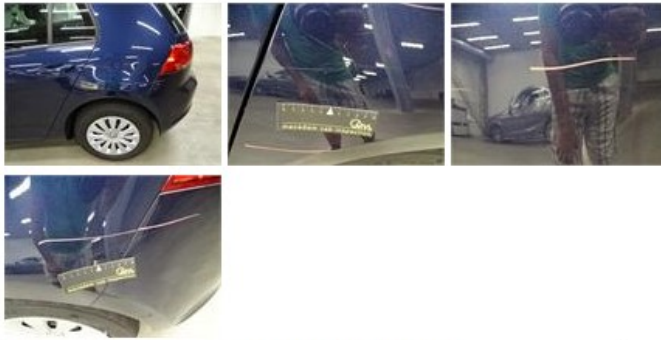
Wing R L, Scratch(es), LI - Repair and paint (complete) 300,20

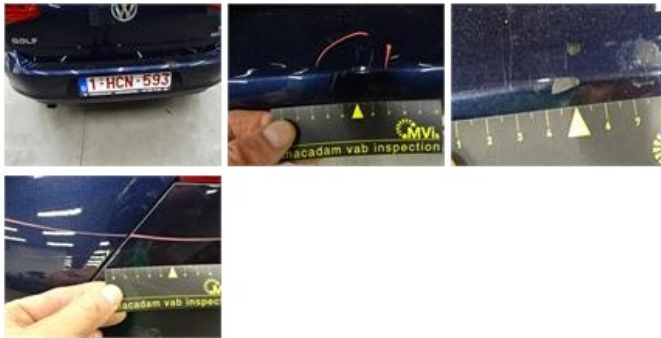
Bumper R, Scratch(es), LI - Repair and paint (complete) 211,80

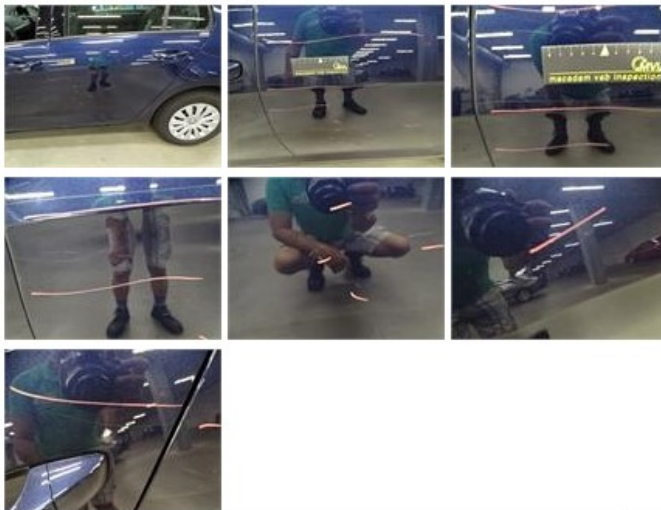
Door R L, Scratch(es), LI - Repair and paint (complete) 318,35
