| BMW 3: 1FML884 | | | |
| Vinnumber: | WBA3K11000F826496 | Versionname: | 3 TOURING 318d 136PK |

| Limited Technical Inspection | | | |

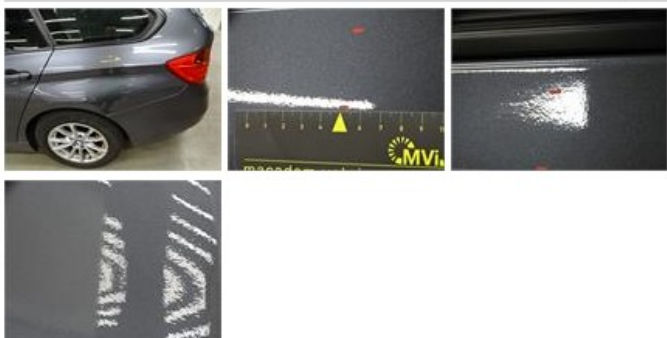
| Wing R L, Bad repair, Acceptable | | | 0,00 |
