BMW 3: 1HNT796

Vinnumber:	WBA3D91040J414698	Versionname:	3 BER 316d 116PK
First Registrationdate:	1/09/2014	Fiscalpower:	
Expertise Mileage:	180524	Power Kw:	85
Bodytype:		Body color:	Dark Blue
Gearbox:	MAN 6 VIT	Paint type:	Metalic
Transmission:	Back	Rims summer:	Aluminium
Fueltype:	Diesel	Oil level:	OK
Maintenance:	19000 KM	Parking lot:	4614
Maintenance:	OK		
Battery functioning:	Yes		
Number of doors:	4		
Number of seats:	5		
Number head rests:	5		
Rims summer:	Aluminium		
Category:	Passenger Car		
Oil level:	OK		
Registration Certificate Car (BE):	Yes

Limited Technical Inspection

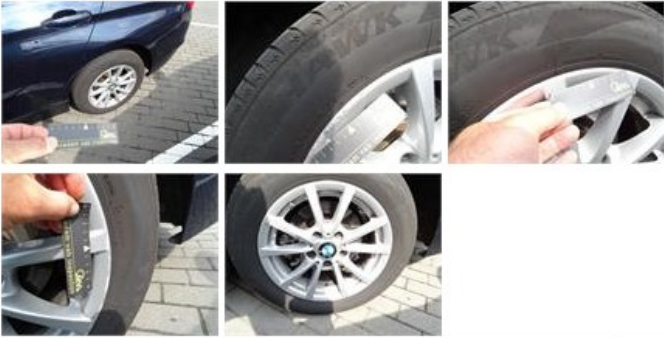
<i>No pictures to display</i>		
Bonnet, Stone chip(s), Acceptable		0,00
<i>No pictures to display</i>		
Rearview mirror R complete, Scratch(es), Acceptable		0,00
<i>No pictures to display</i>		
Boot carpet, Dirty, Cleaning		0,00
<i>No pictures to display</i>		
Alloy rim R L, Scratch(es), 1 - Repair		100,00

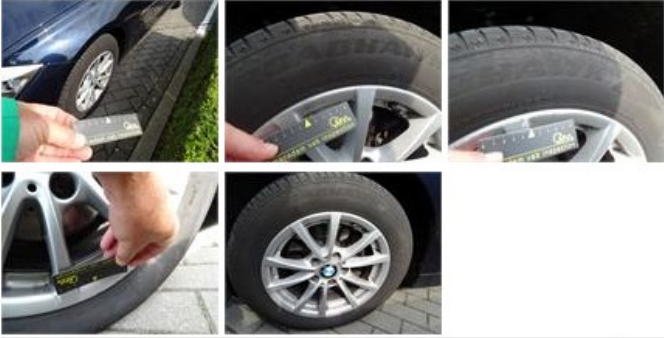
Wing R R, Not original part, Acceptable		0,00
<i>No pictures to display</i>		
Alloy rim F L, Scratch(es), 1 - Repair		100,00

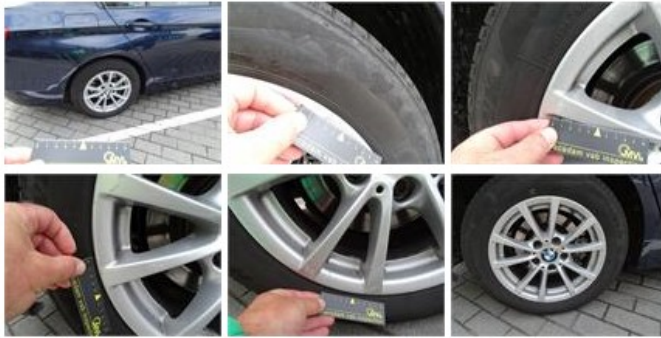
Alloy rim R R, Scratch(es), I - Repair 100,00
