VOLVO V40: 1FOD475

Limited Technical Inspection

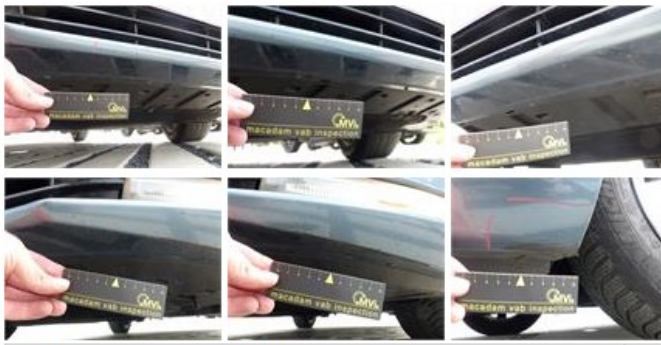
Front bumper, Scratch(es), LI - Repair and paint (complete)	235,80
---	---------------

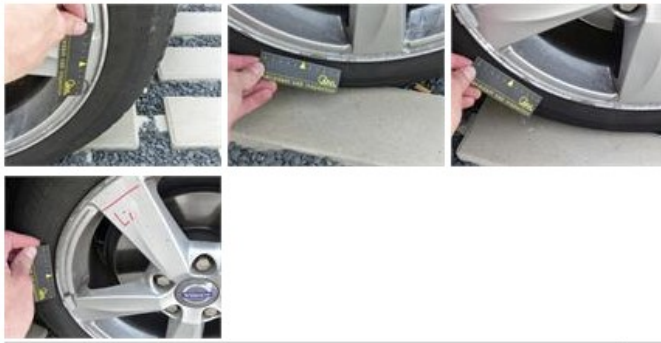
Alloy rim F R, Scratch(es), LI - Repair and paint (complete) 95,00

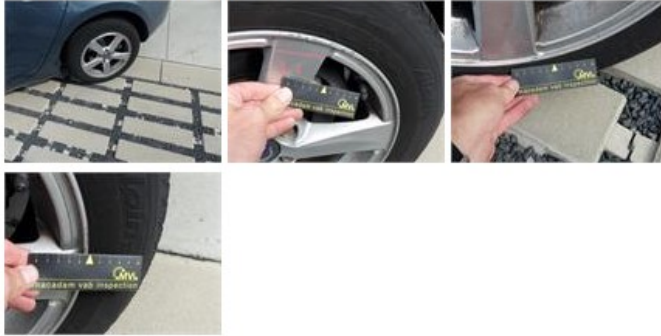
Bonnet, Stone chip(s), Acceptable	0,00
<i>No pictures to display</i>	
Alloy rim R L, Scratch(es), LI - Repair and paint (complete)	95,00
