VOLVO V40: 1FCE266

| Vinnumber: | YV1MZ8451D2010553 | Versionname: | V40 Cr.Country D2 Base |

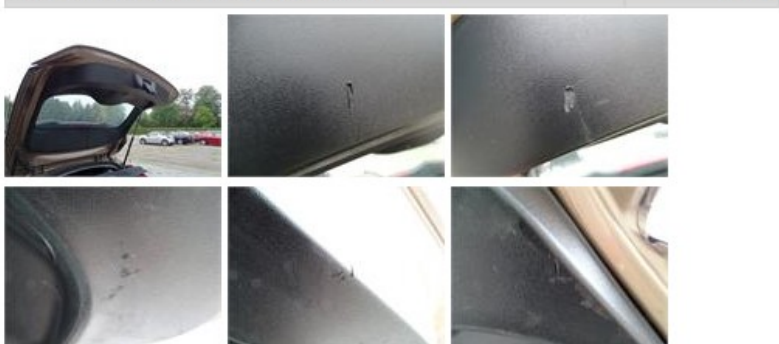
| Trunk lid covering R, Scratch(es), Smart repair | | | 110,64 |

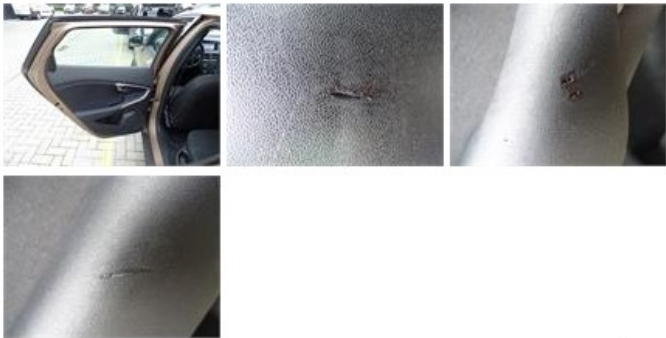
| Door panel R L, Scratch(es), Smart repair | 110,64 |
