VOLVO S60: 1GDR198

| Vinnnumber: | YV1FS73C1E2302710 | Versionname: | S60 BER D4 Kinetic 181PK |

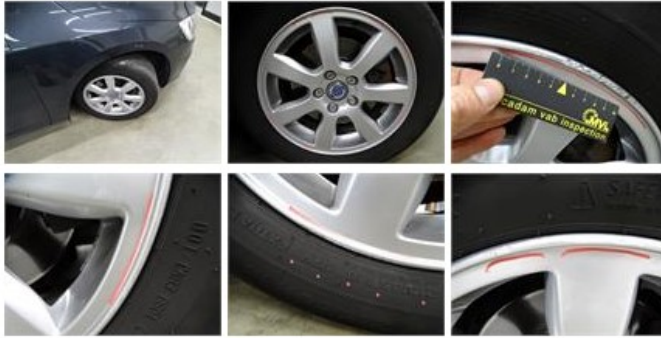
| Alloy rim F R, Scratch(es), LI - Repair and paint (complete) | 95,00 |
