| <b>VOLVO XC60: 1HNZ735</b> | | | |
| Vinnnumber: | <b>YV1DZ87A4F2655780</b> | Versionname: | <b>XC60 D4 4WD Kinetic 163PK</b> |

| <b>Limited Technical Inspection</b> | | | |

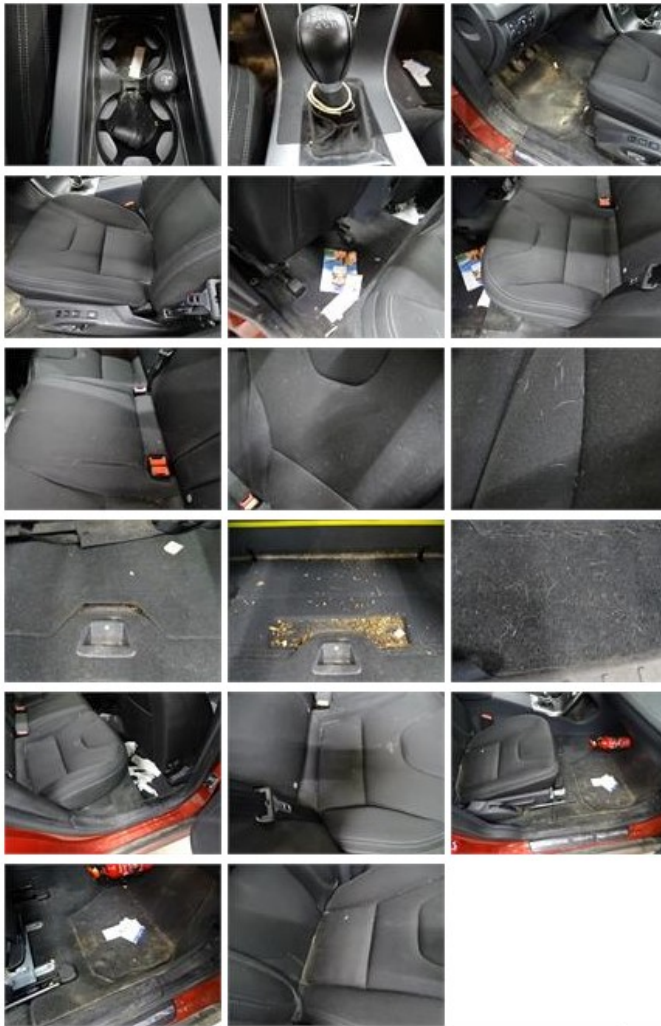
Interior, Dirty, Chemical cleaning 150,00
