BMW 3: 1GHS501

Limited Technical Inspection

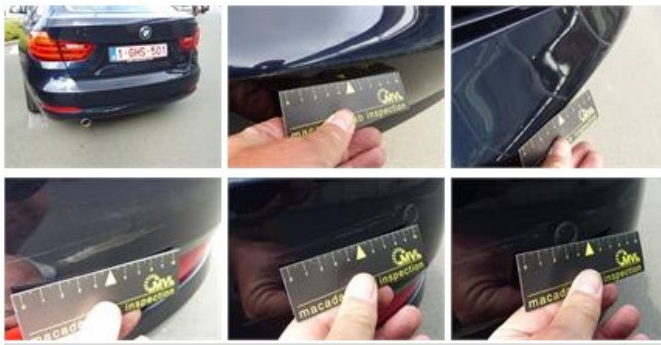
Total cost ex VAT	1498,98
Roof pillar L, Dent(s), Acceptable	0,00
<i>No pictures to display</i>	
Wing R L, Dent(s), Acceptable	0,00
<i>No pictures to display</i>	
Bumper R, Dent(s) and scratch(es), LI - Repair and paint (complete)	283,80
