BMW 1: 1GAQ207

Vinnnumber:	WBA1C91000J518681	Versionname:	1 HATCH 116d Eff.Dyn.Ed. 116PK
First Registrationdate:	9/12/2013	Fiscalpower:	
Expertise Mileage:	52577	Power Kw:	85
Bodytype:		Body color:	Black
Gearbox:	MAN 6 VIT	Paint type:	Metalic
Transmission:	Back	Rims summer:	Aluminium
Fueltype:	Diesel	Oil level:	OK
Battery functioning:	Yes	Parking lot:	2214
Number of doors:	5		
Number of seats:	5		
Number head rests:	5		
Rims summer:	Aluminium		
Category:	Passenger Car		
Oil level:	OK		
Registration Certificate Car (BE):	Yes

Limited Technical Inspection

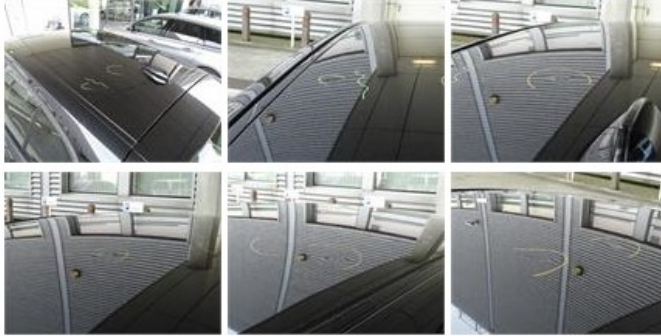
Roof, Chemical pollution, LI - Repair and paint (complete) 553,50
