**BMW 5 TOURING: 1LJK472**

**Limited Technical Inspection**

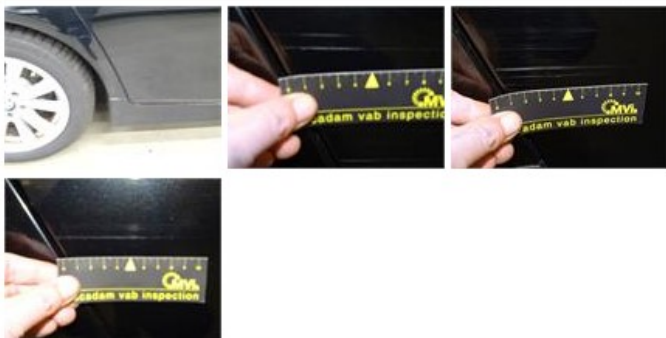
Door R R, Scratch(es), LI - Repair and paint (complete)	<b>382,02</b>
---	---------------
