MERCEDES Vito: 1DUR300			
Vinnnumber:	WDF63960113759777	Versionname:	VITO 113 B/F SWB 136PK
First Registrationdate:	3/09/2012	Fiscalpower:	
Expertise Mileage:	126276	Power Kw:	100
Bodytype:	Transporter	Body color:	Red
Gearbox:	Automatic	Paint type:	Opaque
Transmission:	Back	Rims summer:	Steel
Fueltype:	Diesel	Oil level:	OK
Maintenance:	OK	Parking lot:	1106
Battery functioning:	Yes		
Number of doors:	5		
Number of seats:	3		
Number head rests:	3		
Rims summer:	Steel		
Category:	Light Commercial Vehicle		
Oil level:	OK

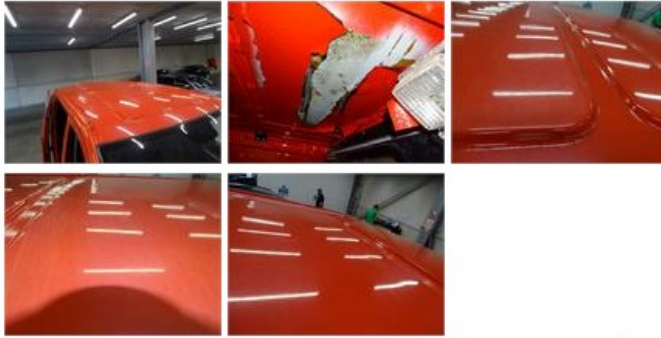
Roof, Bad repair, Paint	0,00
-------------------------	------

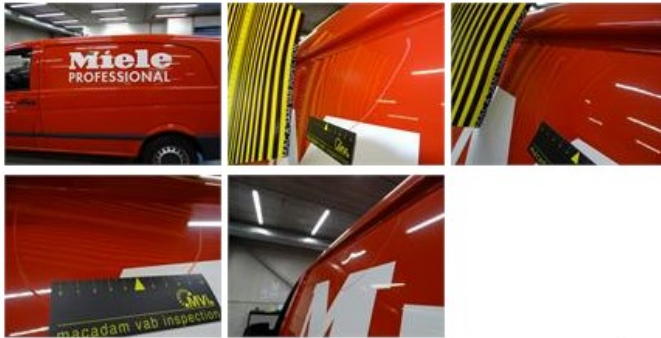
Wing R L, Dent(s), PDR - Knock out without painting	63,00
---	-------
