SKODA Superb: 1FPA642

Limited Technical Inspection

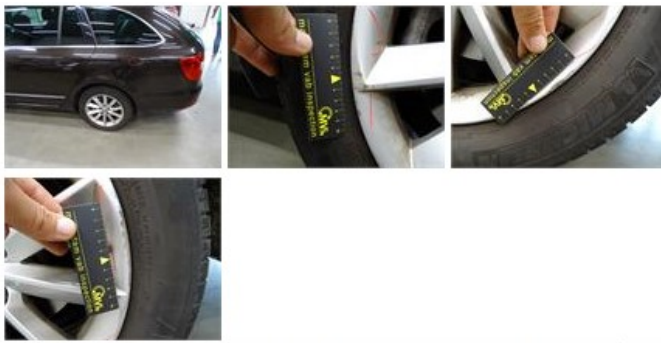
Total cost ex VAT	760,16
Door F R, Scratch(es), 67 - Polish	0,00
<i>No pictures to display</i>	
Tailgate, Dent(s), Acceptable	0,00
<i>No pictures to display</i>	
Door F L, Scratch(es), Acceptable	0,00
<i>No pictures to display</i>	
Alloy rim R L, Scratch(es), LI - Repair and paint (complete)	95,00

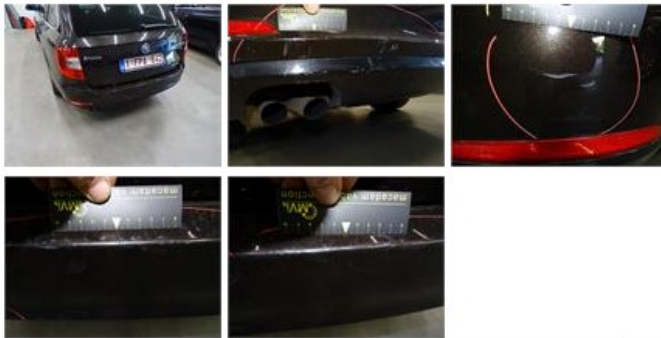
Bumper R, Dent(s) and scratch(es), LI - Repair and paint (complete) 254,16

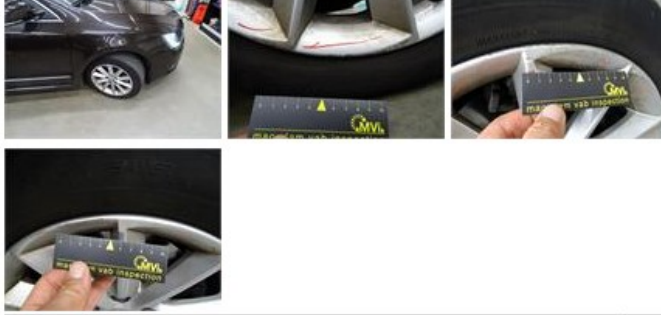
Alloy rim F R, Scratch(es), LI - Repair and paint (complete) 95,00

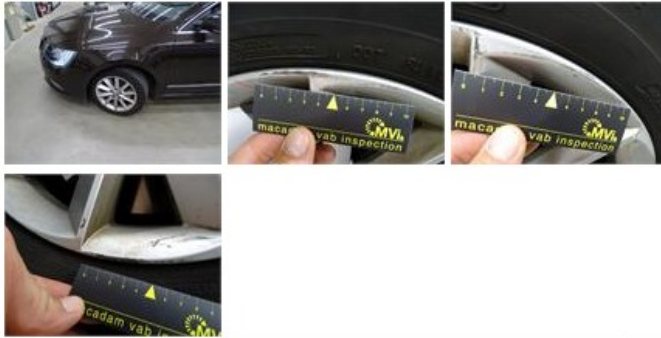
Alloy rim F L, Scratch(es), LI - Repair and paint (complete) 95,00
