## VOLKSWAGEN Touran: 1GGV360

## Limited Technical Inspection

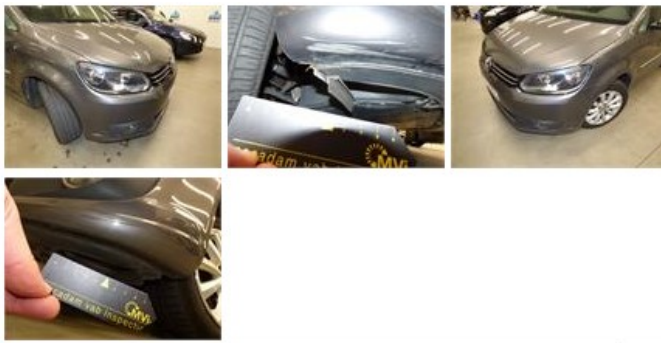
Spare wheel	<b>Yes</b>	Jack	<b>Yes</b>
Total cost ex VAT			<b>598,80</b>
Wing R R, Scratch(es), Acceptable			<b>0,00</b>
<i>No pictures to display</i>			
Dashboard, Scratch(es), Acceptable			<b>0,00</b>
<i>No pictures to display</i>			
Tailgate, Dent(s), Acceptable			<b>0,00</b>
<i>No pictures to display</i>			
Door F L, Scratch(es), 67 - Polish			<b>0,00</b>
<i>No pictures to display</i>			
Bumper F, Scratch(es), LI - Repair and paint (complete)			<b>211,80</b>

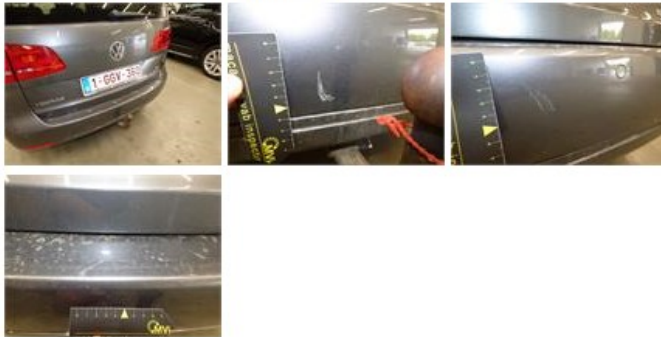
Bumper R, Dent(s) and scratch(es), LI - Repair and paint (complete) 211,80
